FORM 2: TREE RISK ASSESSMENT FORM
表格 2: 樹木風險評估表格

Department 部門:	ArchSD	Inspection Officer 巡查人員:		Post 職位:	ITSQA
File Ref. 檔案編號:	_20160704	Endorsement Officer 覆核人員:		Post 職位:	Project Manager
Date of Inspection (yyyy/mm/dd) 巡查日期:	14-Jun-2016	Last Inspection Date (yyyy/mm/dd) 上次巡查日期:	21-Mar-2016		
Project / Contract No. 合約/工程編號:	TC B928				
Inspection Frequency 巡查週期:	Once every 3 months

Tree ID 樹木編號:	TS013	Departmental reference 部門編號		OVT no 古樹名木冊編號	ARCHSD CW/41				
Tree Species 樹木品種:	Ficus microcarpa								
Location 地點:	Street/ Road No. 門牌號碼	11SW-B/FR260	Street/ Road Name 街道名稱	Hong Kong Park					
	District 地區	A	Nearby Utility Post No. 就近公用設施編號:						
Coordinate 坐標 (HK1980 GRID):	X-Coordinate		Y-Coordinate						
Location Types 地點類別: (multiple answers allowed 可選多於一項)	<input type="checkbox"/> Roadside Landscaped Area 路旁綠化地區		<input type="checkbox"/> Central divider 中央分隔帶		<input type="checkbox"/> Tree pit 樹穴				
	<input checked="" type="checkbox"/> Public Park 公園 / 康樂場地		<input type="checkbox"/> Unallocated Government land 未撥用的政府土地						
	<input type="checkbox"/> Remote countryside 偏遠郊區		<input type="checkbox"/> Recreational site/facilities inside Country Park 郊野公園內康樂用地或設施						
	<in

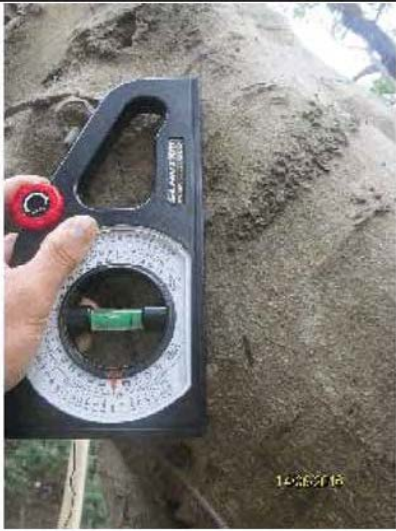
<p>V31 Tilt test 1 (1): Marking</p>

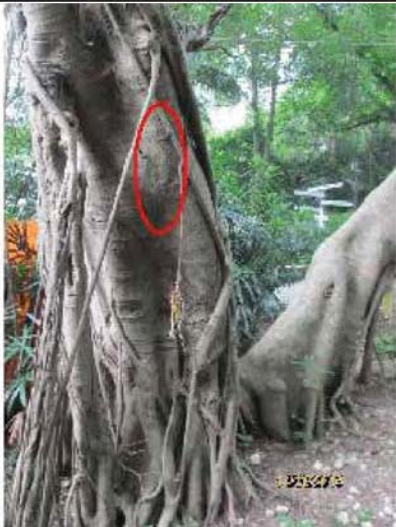
<p>V33 Tilt test 1 (3): Direction 2 Degree: ~ 16</p>

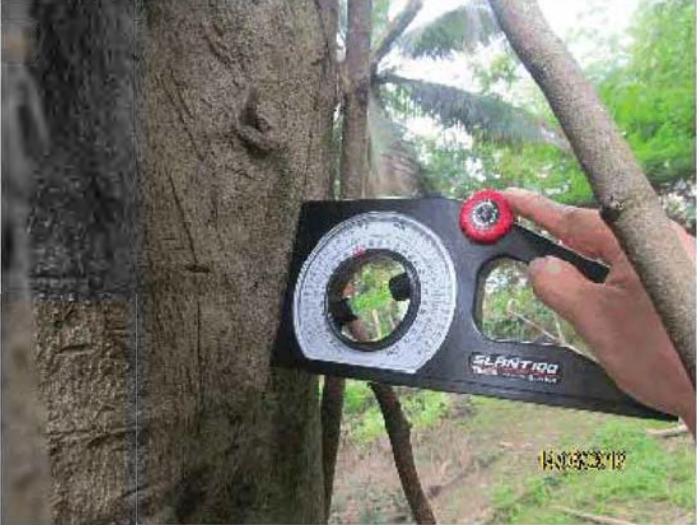
<p>V35 Tilt test 2 (2): Direction 1 Degree: ~ 0</p>

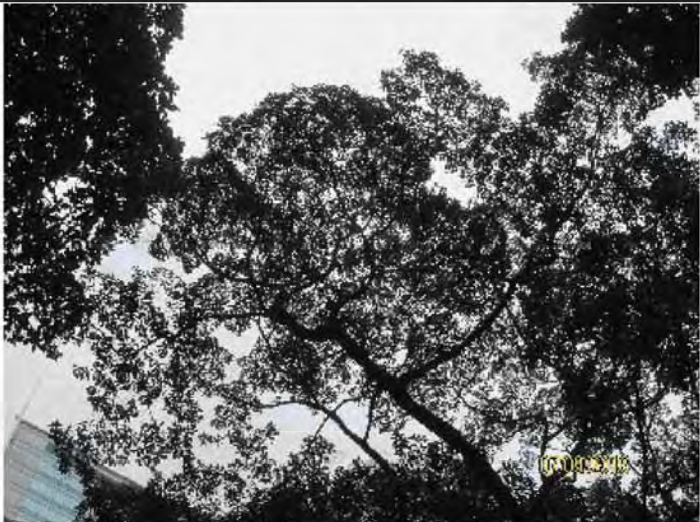
<p>V5 Relative sparse foliage (1)</p>

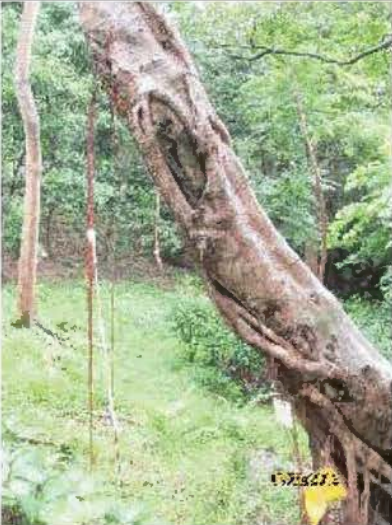
<p>V13 Wound (1)</p>

<p>V14 Wound (2) Extensive growth of aerial roots surrounding the wound</p>

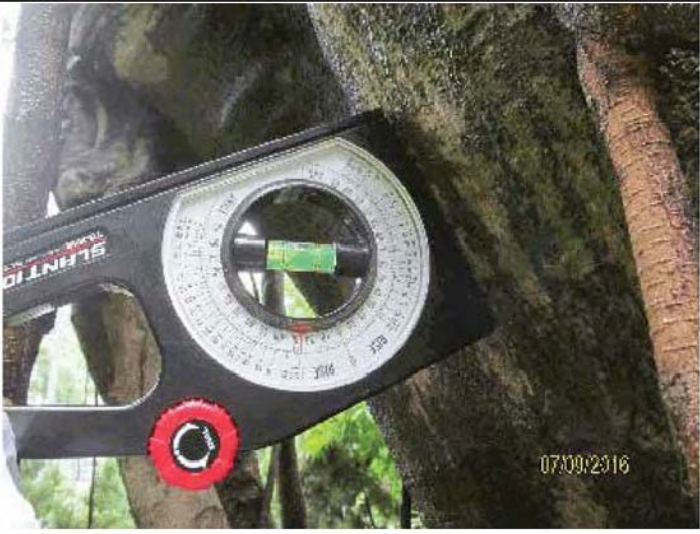
<p>V39 Tilt test 2 (3): Direction 1 Degree: ~ 0</p>

<p>V40 Tilt test 2 (4): Direction 2 Degree: ~ 26</p>

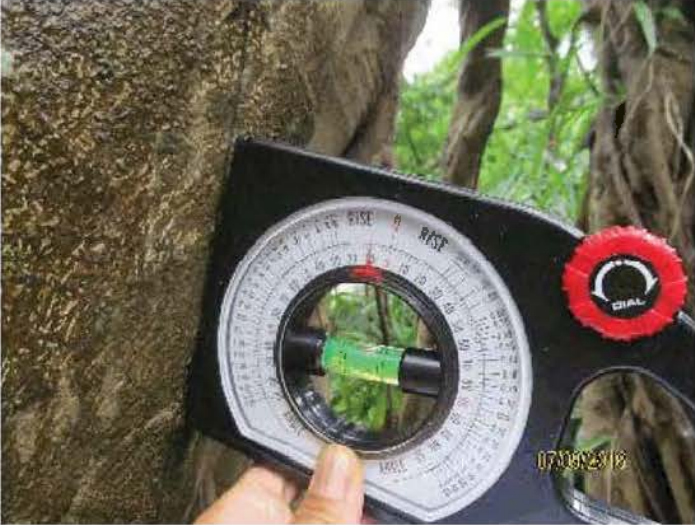
<p>V43 Tilt test 3 (3): Direction 1 Degree: ~ 0</p>

<p>V44 Tilt test 3 (4): Direction 2 Degree: ~ 10</p>

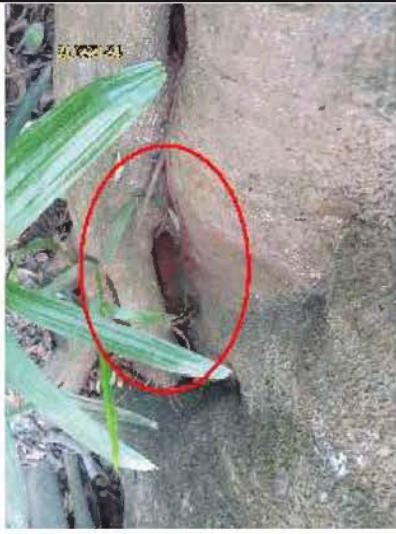
<p>V29 Fungi (3): Spore</p>

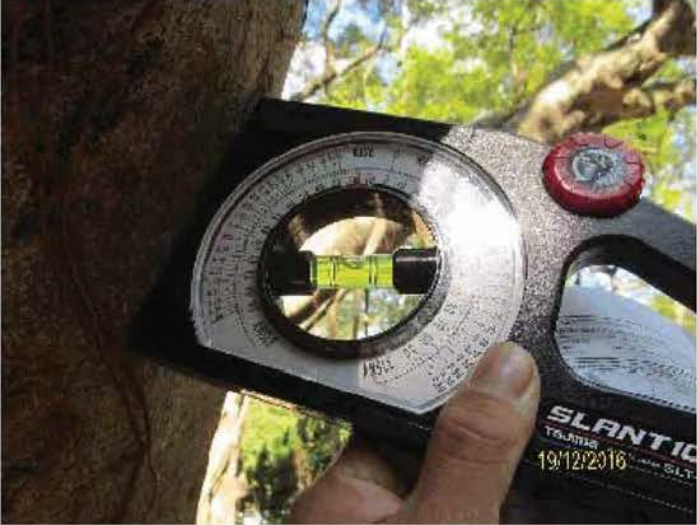
<p>V35 Tilt test 1 (3): Direction 1 Degree: ~ 0</p>

<p>V36 Tilt test 1 (4): Direction 2 Degree: ~ 16</p>

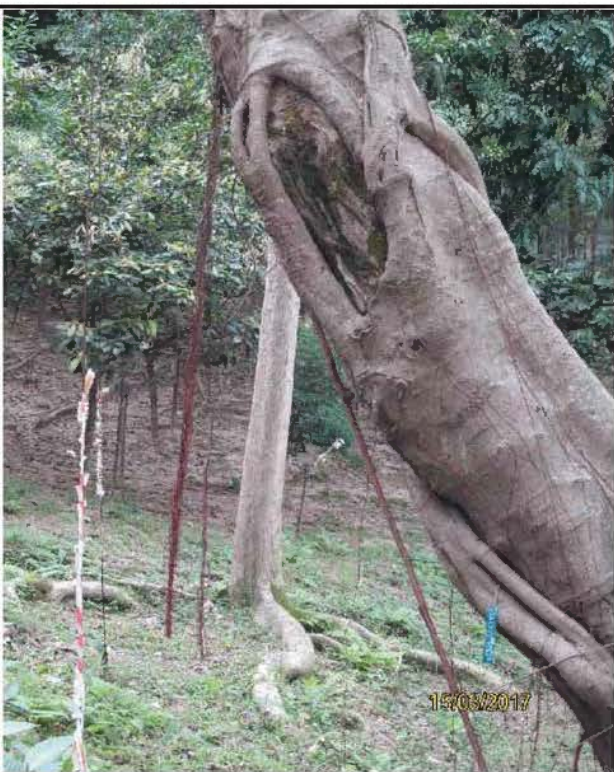
<p>V9 Aerial roots condition (1)</p>

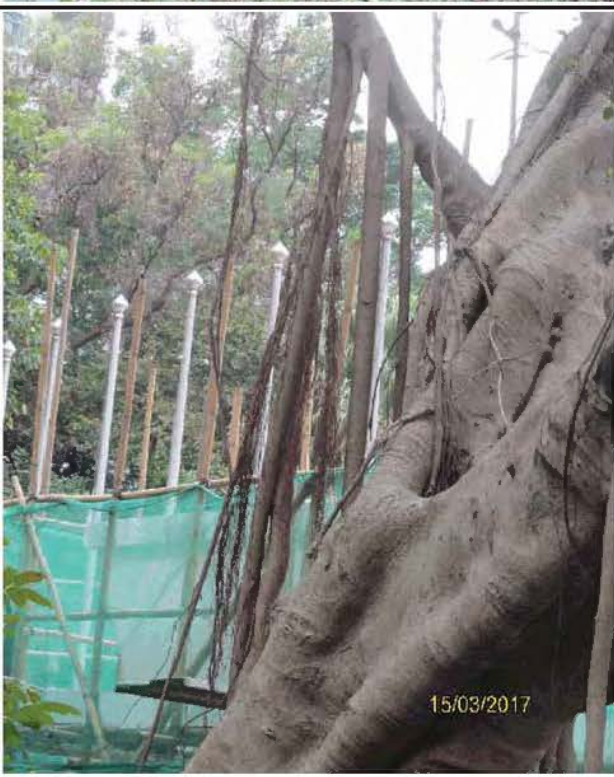
<p>V10 Aerial roots condition (2)</p>

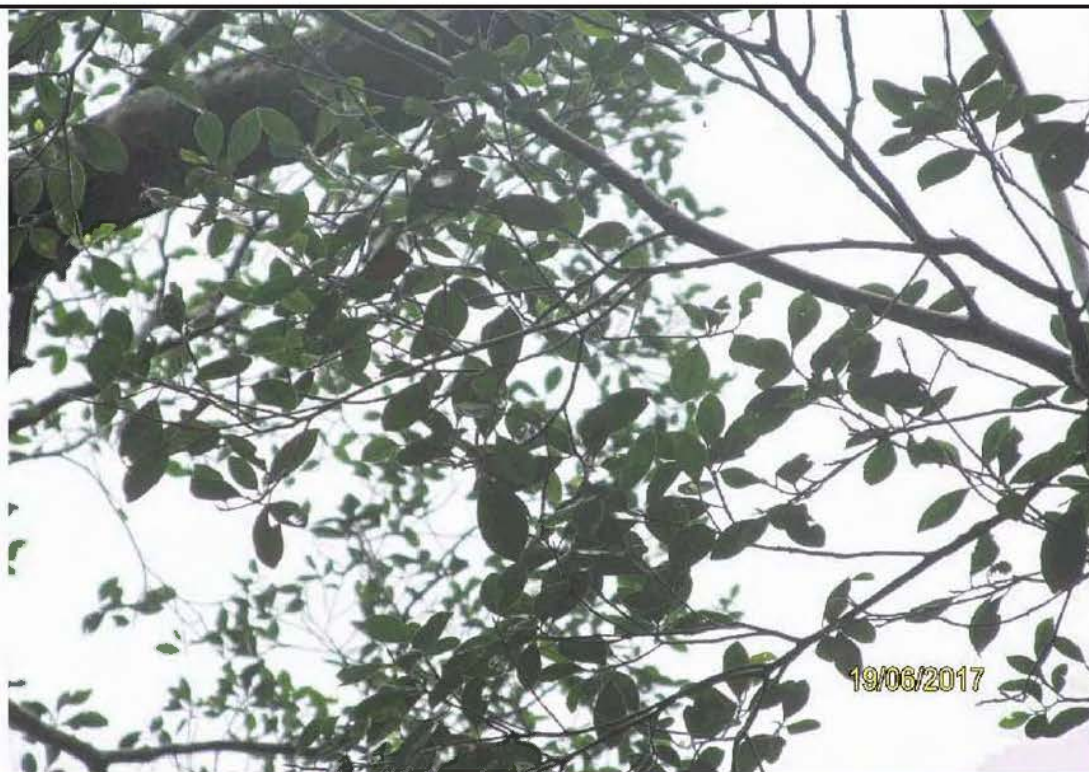
V21 Foliage condition (1)

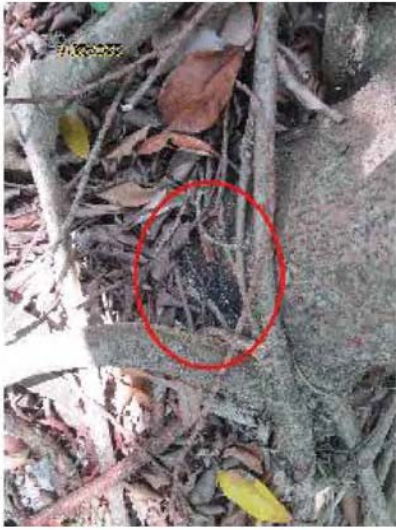
<p>V11 Minor surface root rot (1)</p>

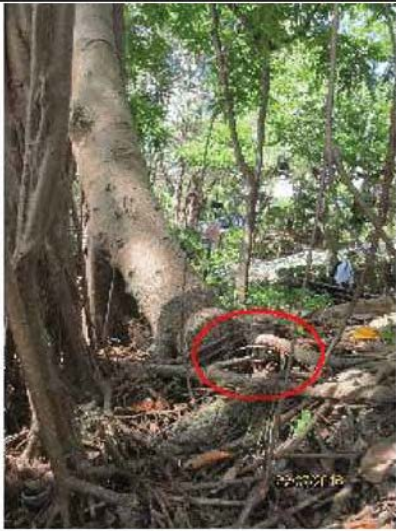
<p>V12 Minor surface root rot (2)</p>

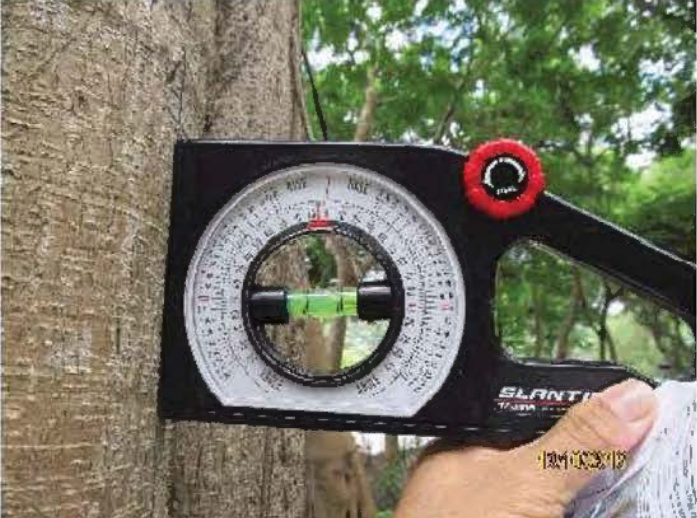
<p>V19 Tilt test 1 (3): Direction 1 Degree: ~ 0</p>

<p>V20 Tilt test 1 (4): Direction 2 Degree: ~ 5</p>

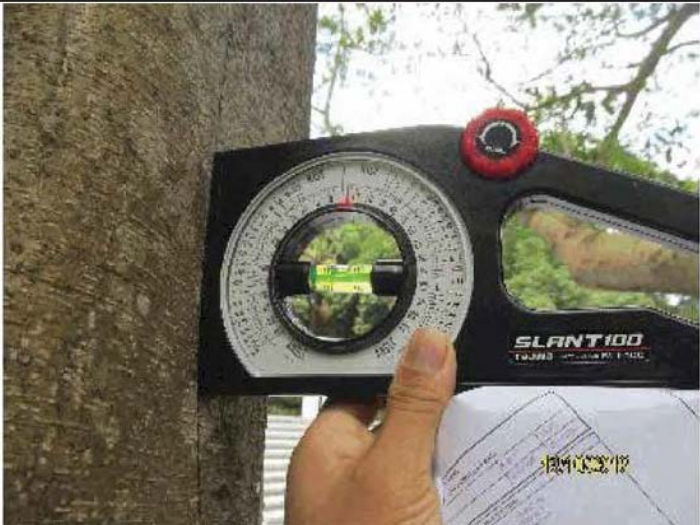
<p>V23 Tilt test 2 (3): Direction 1 Degree: ~ 0</p>

<p>V24 Tilt test 2 (3): Direction 2 Degree: ~ 4</p>

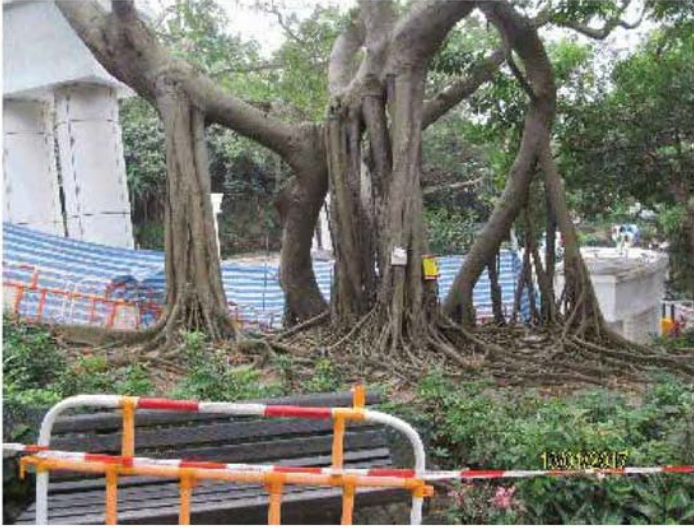
V15 Site restricted by construction works

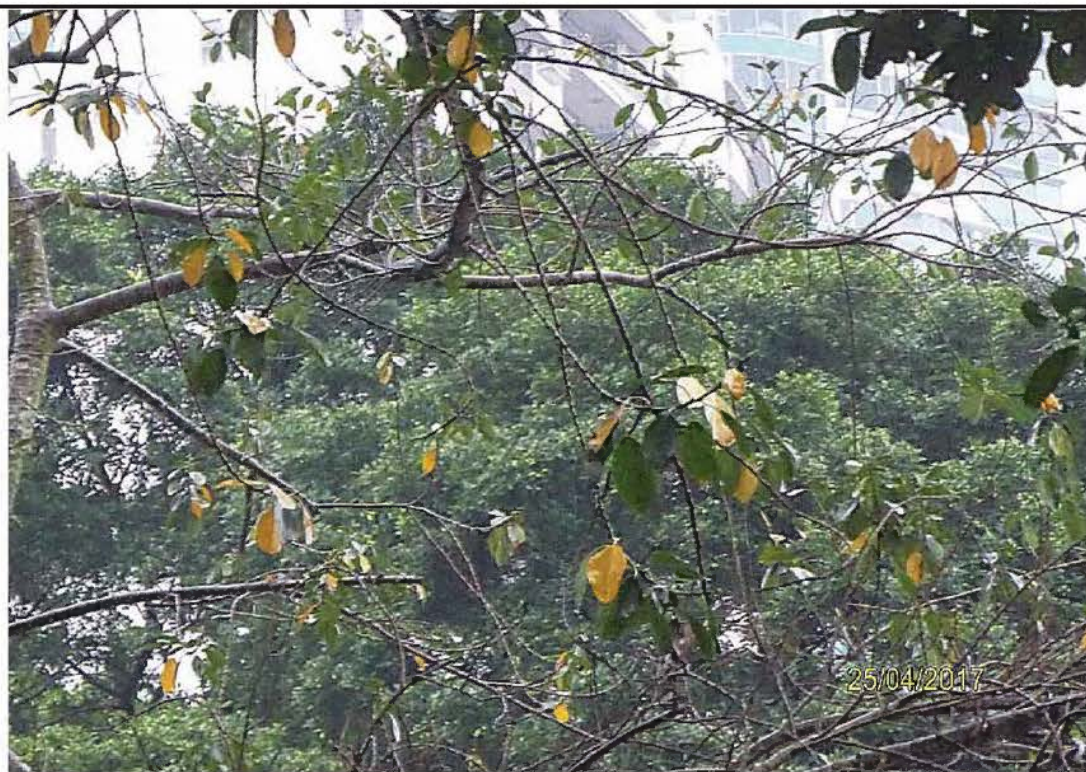
V11 Yellow leaves (1)

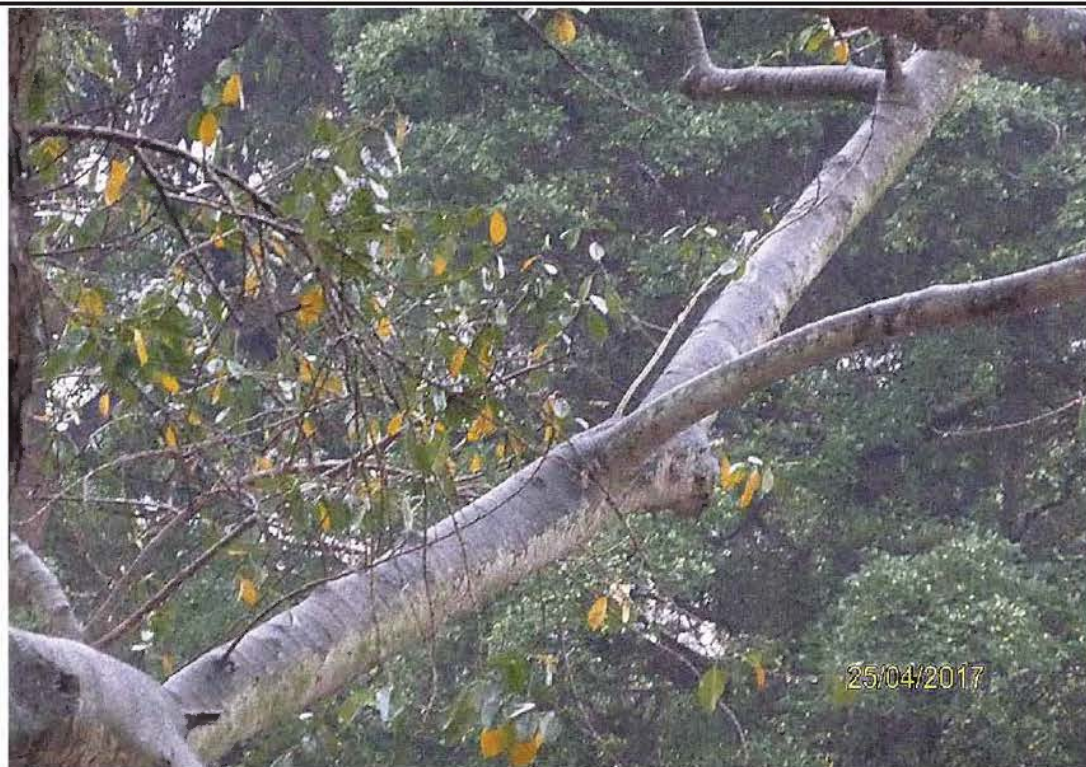
V12 Yellow leaves (2)
