**Assessment Report on  
Feasibility of Tree Support Systems proposed in  
Study on Stonewall Trees on Slope no. 11SW-A/R577  
Bonham Road, Hong Kong**

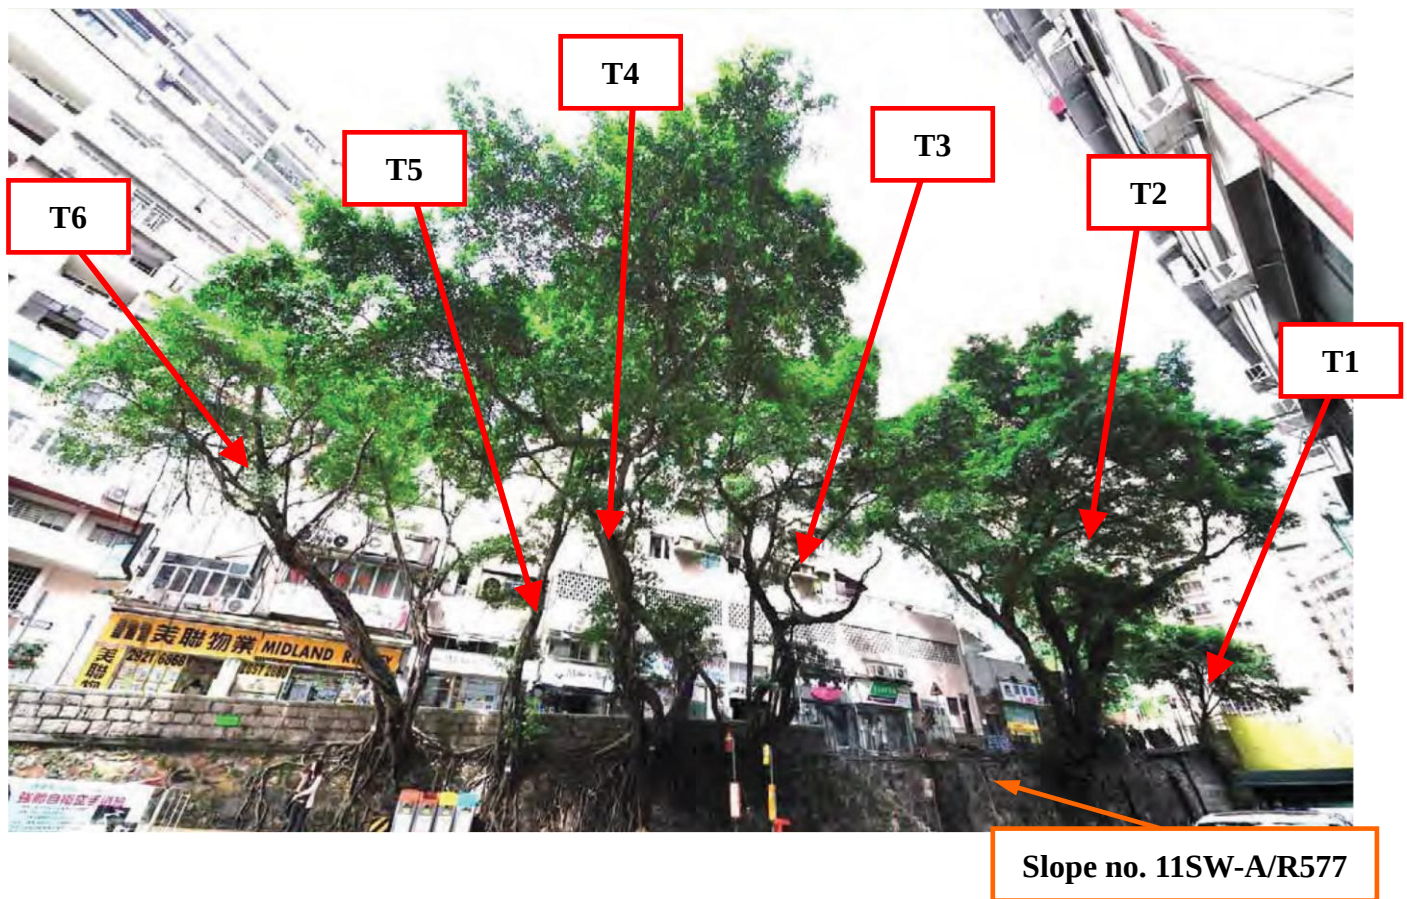
Photo 1.1 – Overall view of the 6 stonewall trees

- (i) T1 – This is a small tree with little structural problem or decay problem. Tree hazard assessment has a score of 5 (see remarks below) and is rated as **low risk level**.

- (ii) T2 – This is an Old and Valuable Tree (OVT) with the Registered Number LCSD CW/14. The tree is generally in good health and has a well-formed scaffold. Tree hazard assessment has a score of 5 and is rated as **low risk level**.

- (iii) T3 – This is a semi-mature size tree with much confined scaffold development. Tree hazard assessment has a score of 5 and is rated as **low risk level**.

- (iv) T4 – This is a twin stemmed mature size tree which is the most tilted of the 6 stonewall trees at the site. The tree has low live crown ratio and incipient anchorage failure. Tree hazard assessment has a score of 9 and is rated as **medium risk level**. However, as the tree has one additional risk factor [root detachment from stonewall], it is therefore described as **alarming risk**.

- (v) T5 – This is a mature size tree with low live crown ratio, narrow & confined crown and

large cavity with decay at the trunk base. Tree hazard assessment has a score of 8 and is rated as **medium risk level**. However, as the tree has one additional risk factor [large trunk base cavity], it is therefore described as **alarming risk**.

- (vi) T6 – This is a twin stemmed mature size tree with heavy lean, asymmetrical crown. Tree hazard assessment has a score of 5 and is rated as **low risk level**.

- 4.1 In view of the significant risk to public safety and in accordance with the general advice promulgated by DEVB<sup>4</sup>, the trees T4 and T5 are recommended to be felled as soon as possible before the onset of typhoon season in May this year, as well as to follow the requirement of prompt action for the completion of necessary action to remove the identified risks of problematic trees.

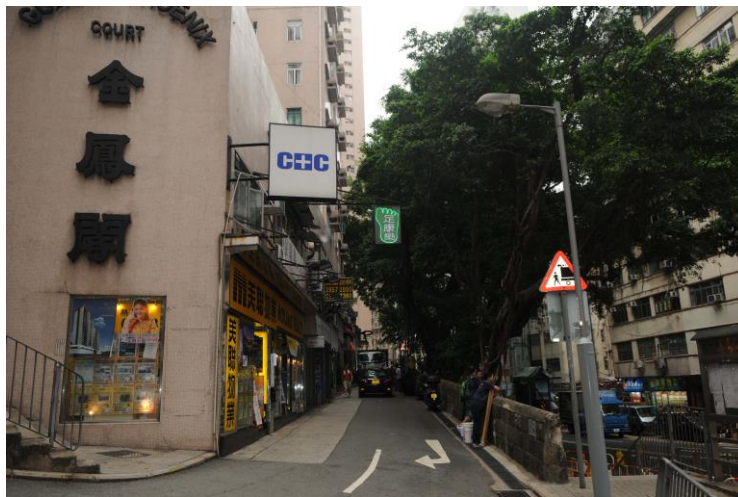
Photo 2.1 – General view of nearby building

- (i) There are no statutory powers for government authorities including HyD to anchor the cable system on private structure/building. The general view of nearby building is shown on Photo 2.1. As the building facade does not belong to individual owner, consents from owners' incorporation or all building owners are required. However, there is no incentive for the building owners to agree the installation of cables on their building. Furthermore, as extra loading due to cable anchorage will be applied on the building, the liability and maintenance issues are difficult to be resolved. The works will also affect and limit future maintenance of building facade and redevelopment of the building.

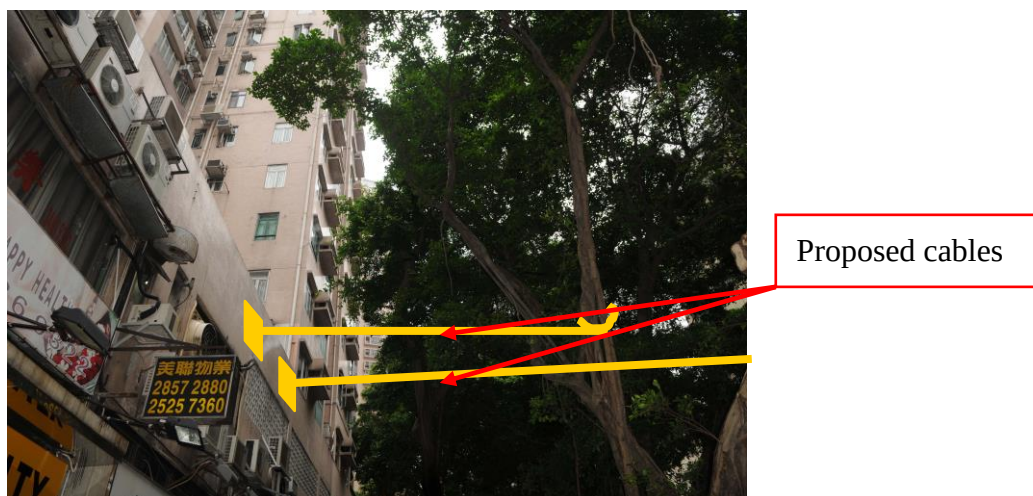
Photo 2.2 – Proposed cables anchor on the nearby building

- (iii) As a minimum headroom<sup>1</sup> of 5.1m has to be maintained at St. Stephen's Lane for vehicular traffic, the cables should be mounted at a high position of the tree where the tree branches may not be strong enough to take the high tension forces. (Photo 2.2)
- (iv) The structural stability of the building will be affected due to the extra loading from the cable system which has not been allowed for in the original design of the building. The stability of the building is required to be reassessed and strengthening works on the building will probably be required. Submission to Buildings Department for their approval is also required for the proposed works and it will take considerable time for the required processes while the public is being exposed to the risk of tree failure.

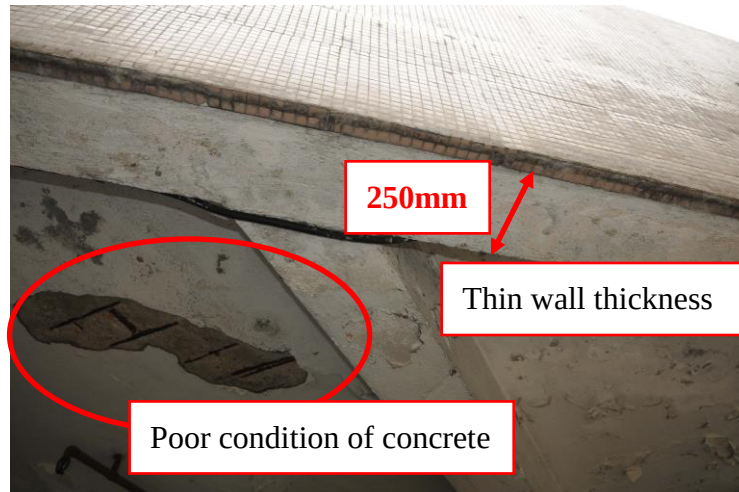
Photo 2.3 – Existing condition of nearby building

- (ii) Even if agreement can be obtained from the owners, the anchorage of the proposed cable bracing system will have to be provided at the facade of the common podium of the nearby Golden Phoenix Building to avoid potential structural and visual impact to individual residential units. With this cable supporting system, large tension force (in the order of 30 tonnes for T4 and 4 tonnes for T5) will then be induced in the cables to support or stabilise the tree due to the dead weight of the tree and wind loads acting on the tree. There can be detrimental damage to the adjacent buildings and severe injury to the public caused by the immense destructive force from the failure of trees/branches/cables and associated parts during typhoon or strong gust/monsoon wind. It is estimated that two anchorage plates of 550mm x 550 mm size with four 24mm diameter high tensile strength bolts anchoring 210mm in the building are required (with at least 270mm thick concrete being required to hold the bolts). However, as the building is quite old, the condition of concrete is uncertain. Moreover, the estimated wall thickness is only 250mm (Photo 2.3). Therefore the suitability of the anchorage is in doubt. The anchorage depth of 210mm

would also affect the existing reinforcements inside structural members of the building.

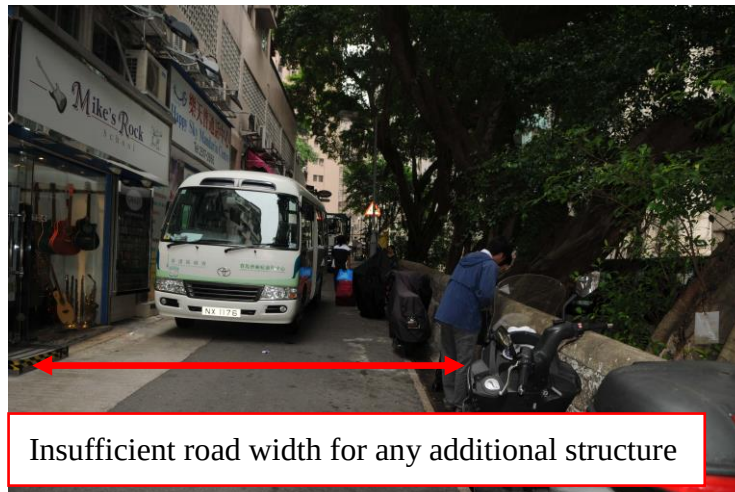
Photo 2.4 – St. Stephen Lane

- (i) St. Stephen's Lane is a one-lane two-way carriageway of about 4.5m width, being shared use with pedestrians. The existing road width is not up to current standard due to site constraints. The road width at the location of Tree T4 and T5 are 4.25m and 4.50m respectively. As the absolute minimum carriageway width requirement for a single track access road serving as emergency access<sup>2</sup> is 3.5m and the horizontal clearance requirements for carriageway to building/structure/obstruction<sup>3</sup> is 0.5m on each side, the existing road width is already below or at the minimum standard. It is not viable to install any structures at St. Stephen's Lane due to the road width constraint. (Photo 2.4)

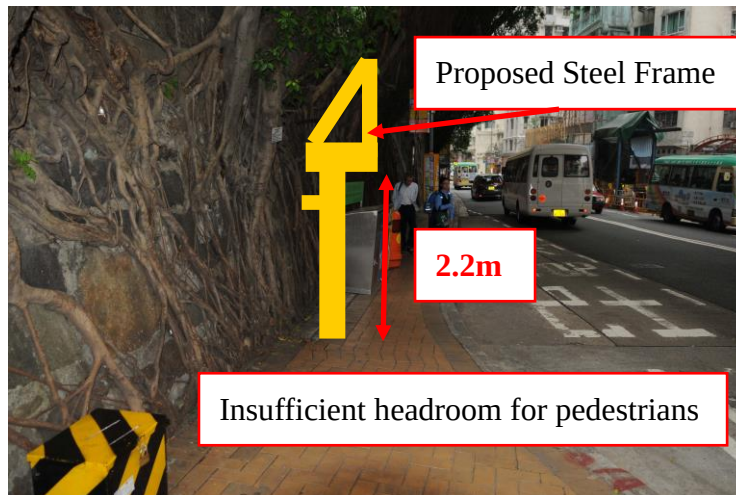
Photo 2.5 – Southern footpath at Bonham Road (viewing from the east)

- (i) From our survey, the lower part of the tree is only 2.5m above the existing footpath at Bonham Road. The estimated size of the supporting beams is 0.3m in depth. As such, minimum headroom of 2.3m for footpath cannot be maintained if the supporting frame is to be constructed on the masonry wall adjacent to the footpath. (Photo 2.5)

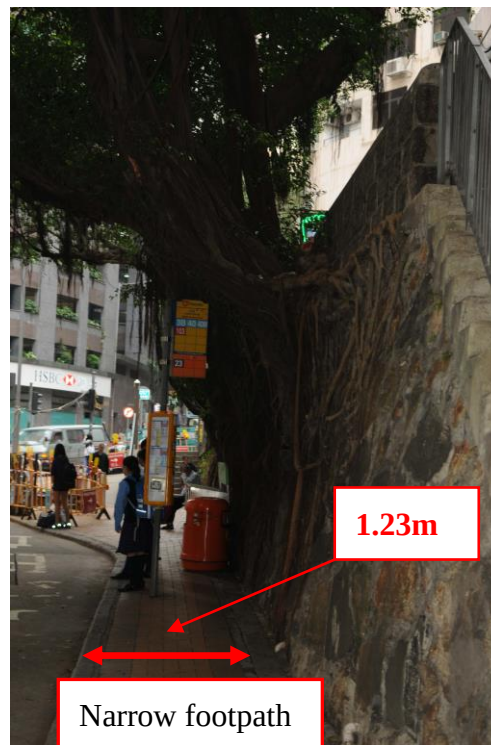
Photo 2.6 – Southern footpath at Bonham Road (viewing from the west)

- (i) The existing footpath width near tree T4 and T5 is only 1.23m (Photo 2.6) which is not up to current standard. It is already too narrow to accommodate both pedestrians and passengers waiting at the bus stop. The construction of structures occupying extra footpath spaces is therefore impractical.

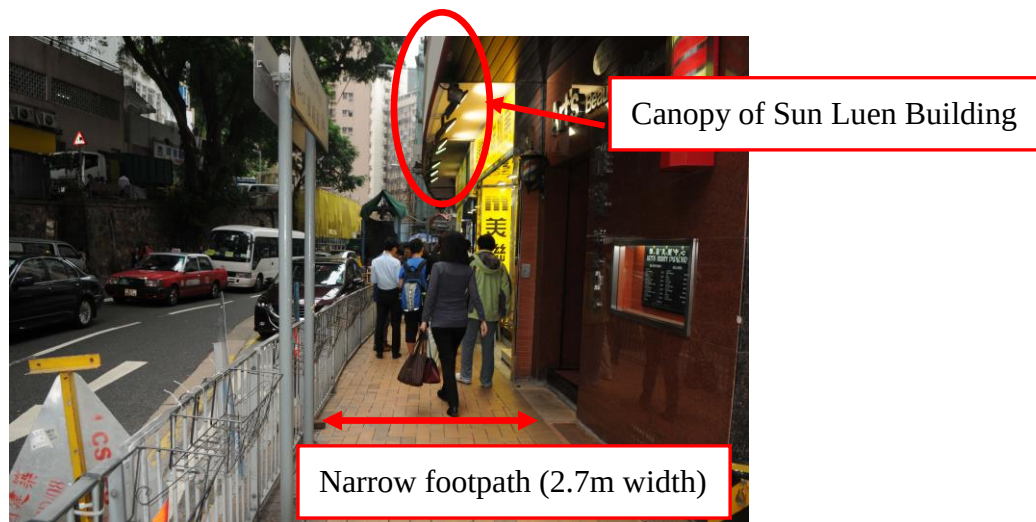
Photo 2.7 – Northern footpath at Bonham Road

- (ii) The footpath at the opposite side is 2.7m wide only. In addition, the existing canopy of Sun Luen Building will obstruct the steel structure (Photo 2.7). With the 0.5m clearance requirement from the carriageway and 0.5m width for beam barrier, there is insufficient footpath space to accommodate the massive structure steel post (about 1m width steel post).
