**地政總署**  
**建議移除位於般咸道**  
**香港大學鄧志昂樓前兩株大樹**

## 附件二

## Tree Risk Assessment Form 2 - Individual Tree

## T1 Form 2 Photo Record

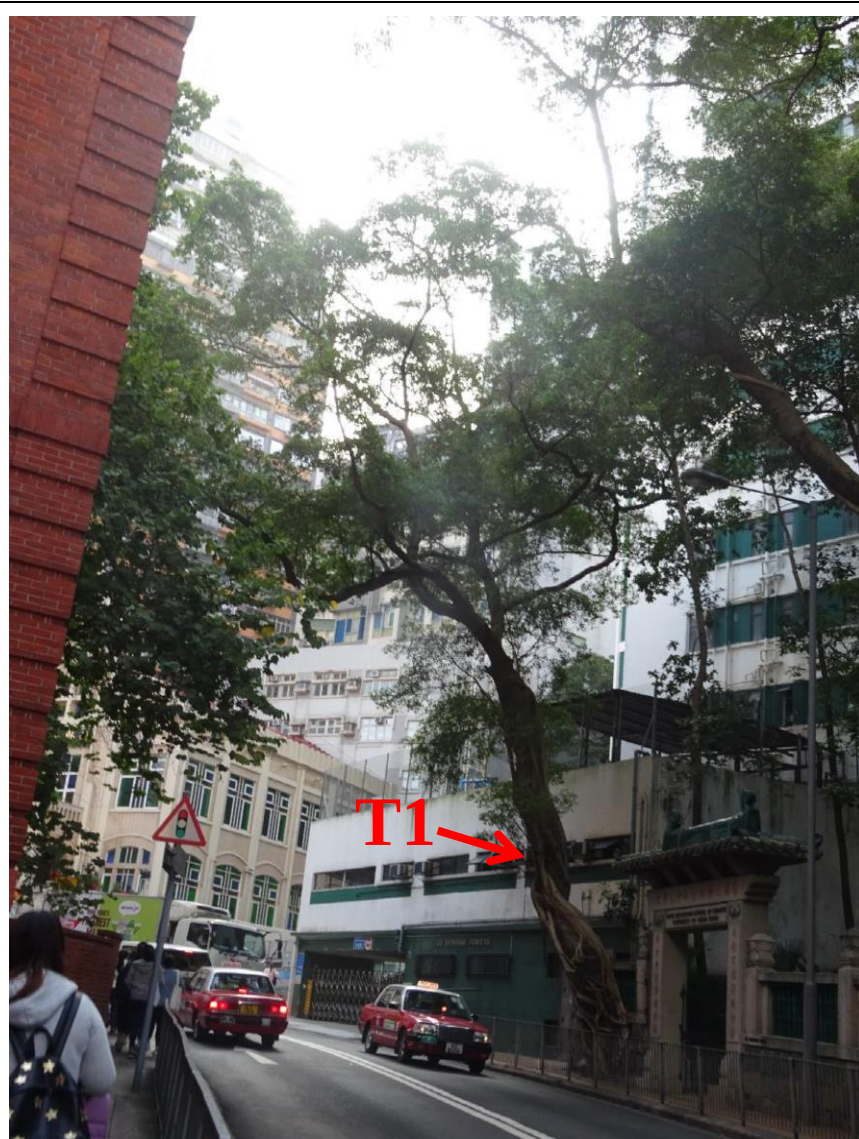
- (i) 兩株榕樹樹身向般咸道方向傾斜(T1 及 T2 分別傾斜 30 度及 15 度)；
- (ii) 兩株榕樹健康情況差，葉片稀疏，活樹冠比例偏低及樹冠不對稱；
- (iii) 兩株榕樹的根部均被擠壓於狹窄的行人路上，部分樹根外露並纏繞在相鄰的矮牆上；
- (iv) 榕樹(T1)上發現樹洞(約 30x 30 x 20 厘米)，樹洞中央有明顯內部腐爛跡象；及
- (v) 另一株榕樹(T2) 上發現樹洞(約 50 x 30 x 20 厘米)，的樹基上亦發現真菌子實體，顯示受到真菌感染，影響該樹的結構。

T1: 位於牌坊右方的榕樹

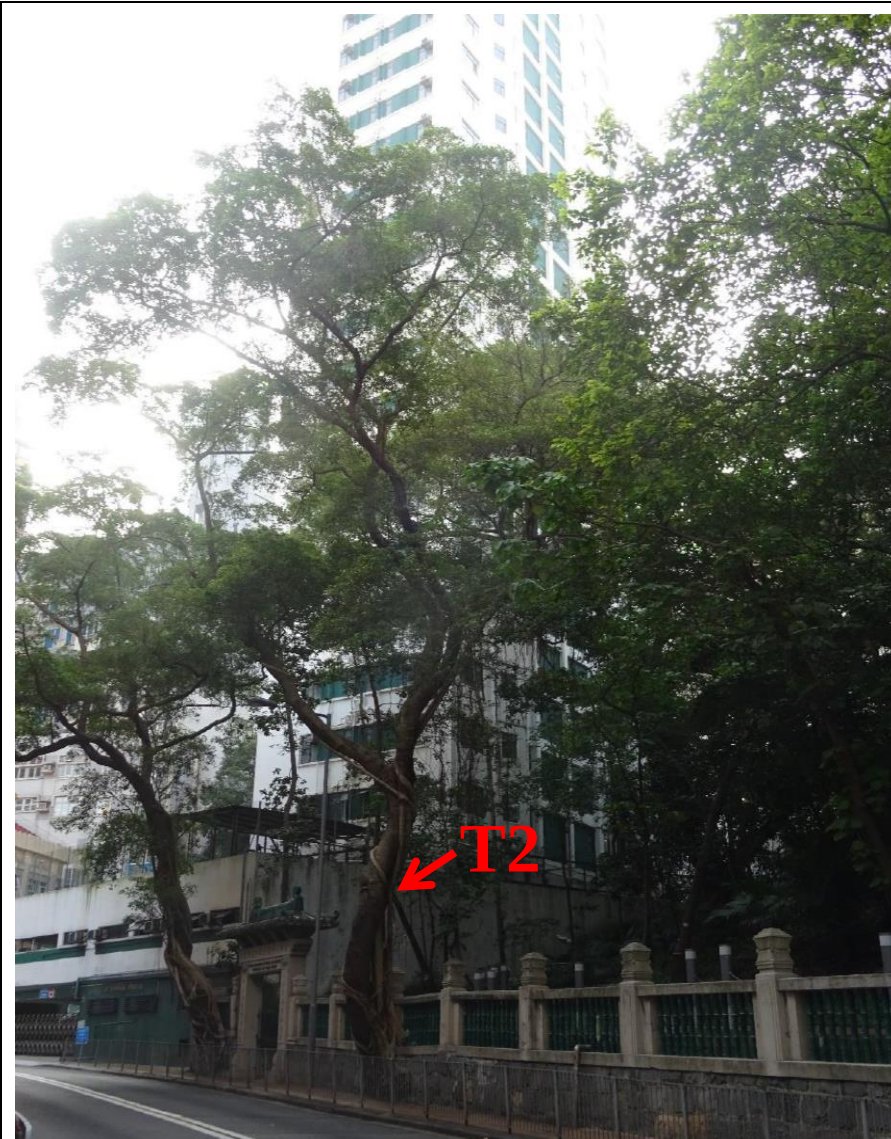
T2: 位於牌坊左方的榕樹

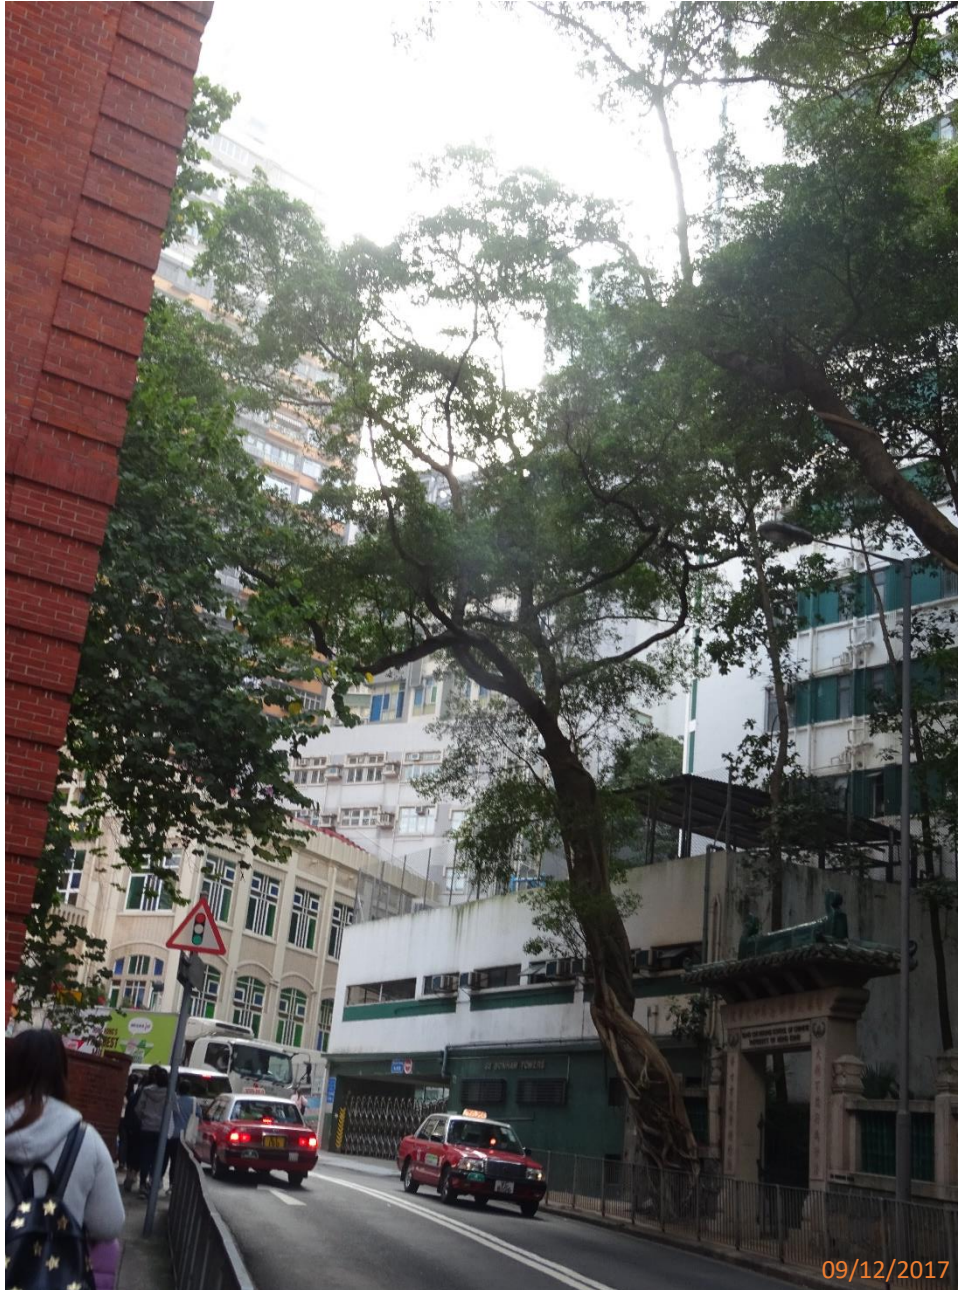
T1 *Ficus microcarpa* 細葉榕

At the time of inspection, T1 had poor health since sparse foliage density was observed. Structurally, the tree was leaning at about 30 degree with unstable root-plate towards the Bonham Road and tendency of trunk growth was conflicting with the pedestrians Restricted by the pavement, retaining structure and footing/railings, the rooting conditions were very unfavorable. Girdling root was observed and therefore, the tree was structurally weak. The root spread on masonry wall was surface attachment only and with unknown amount of root penetration to the slope behind. The surface area of the retaining wall for tree anchorage was small and therefore, the wall may also fails when T1 fails or vice versa (overall failure). The mode of failure will be similar to the one failed at slope no. 11SW-A/R577 at Bonham Road on 22 July 2015. Cracks were observed on the retaining structure and planter behind which may be caused by the root-plate movement of the T1. In the short term, additional structural support such as cabling and wiring, metallic framework are highly recommended to stabilize the tree. However, there are site constraint of limited space for additional structural support at the slope side. In the long term, the failure potential of T1 is high due to its weak structure which pose risk to the buildings, traffic and the pedestrians and thus, tree removal is recommended.

Overview of T1: Leaning at about 30 degree towards the Bonham Road

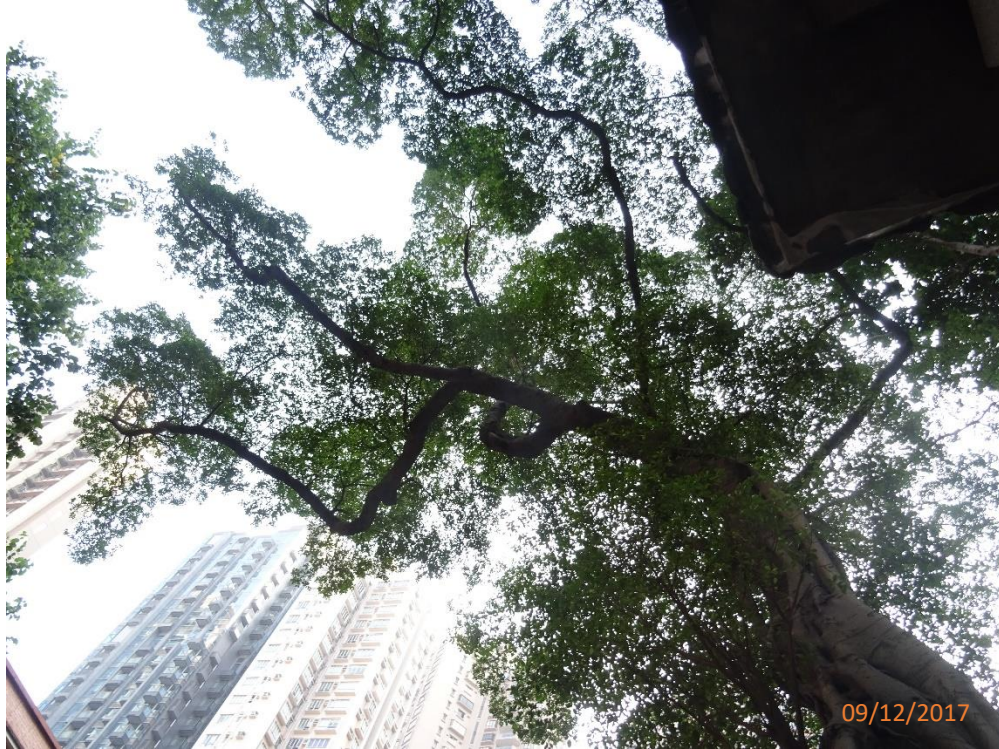
Crown condition: Sparse foliage density; Crown reduced before

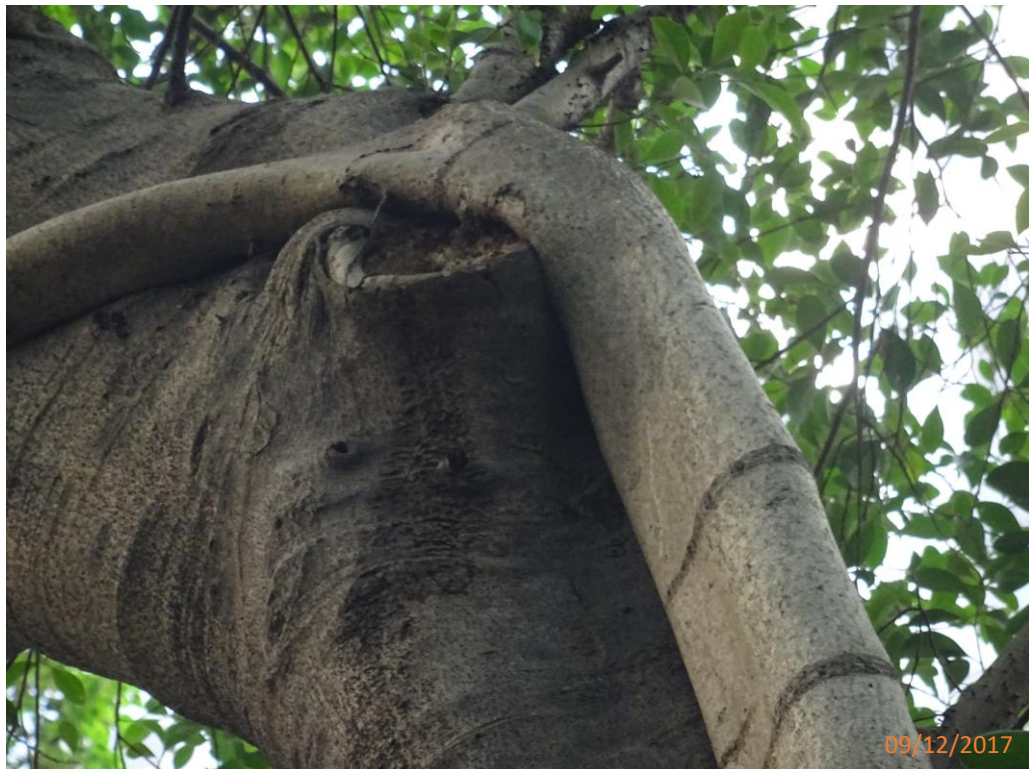
Branch Condition: Wounds

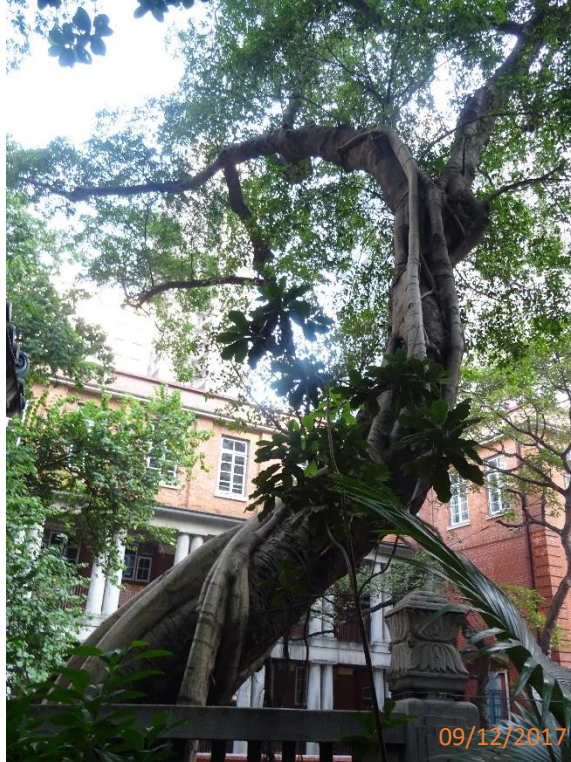
Branch Condition: Abrupt bends

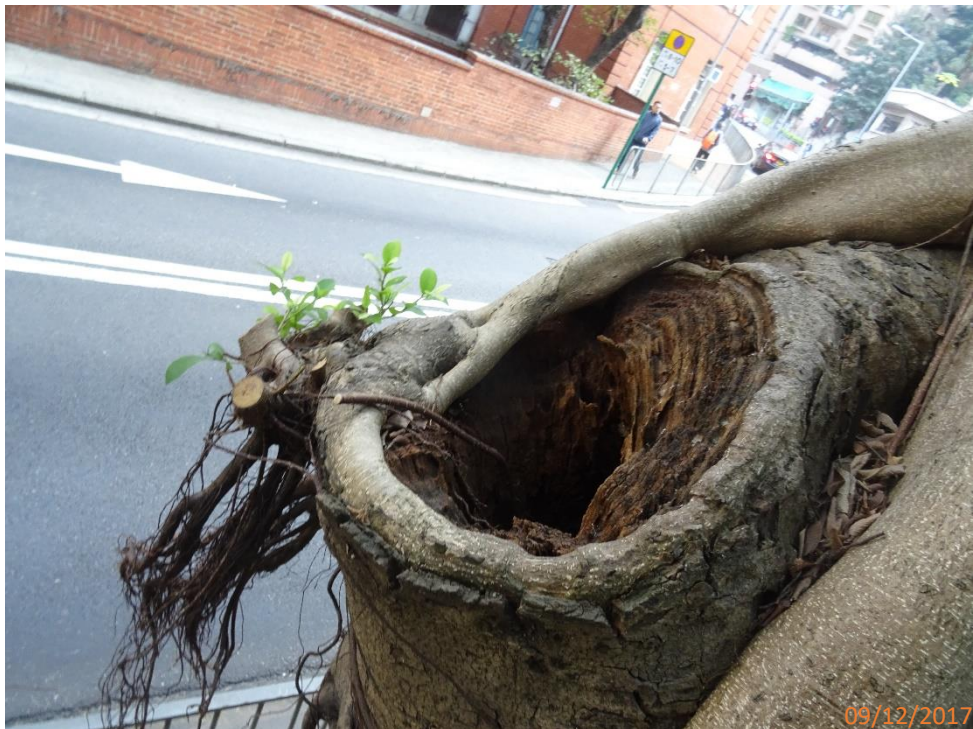
Trunk condition: Cavity 300mm length, 300 length, 250mm depth

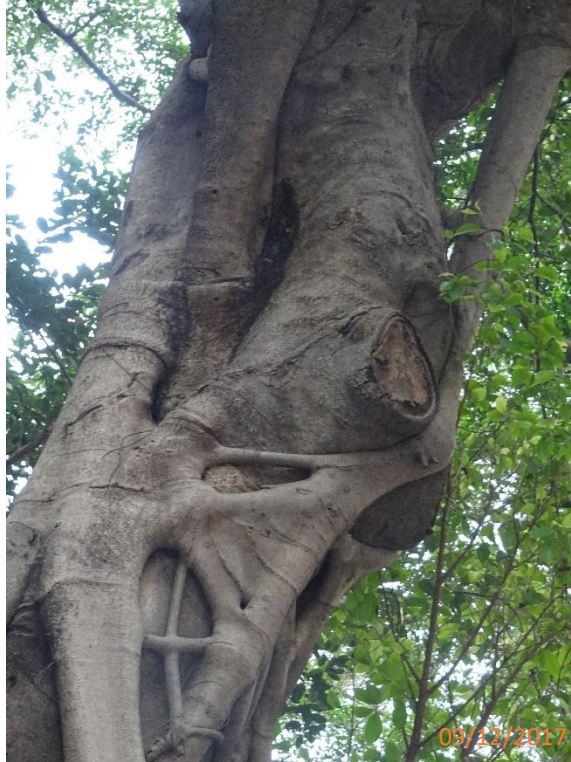
Trunk condition: Wounds

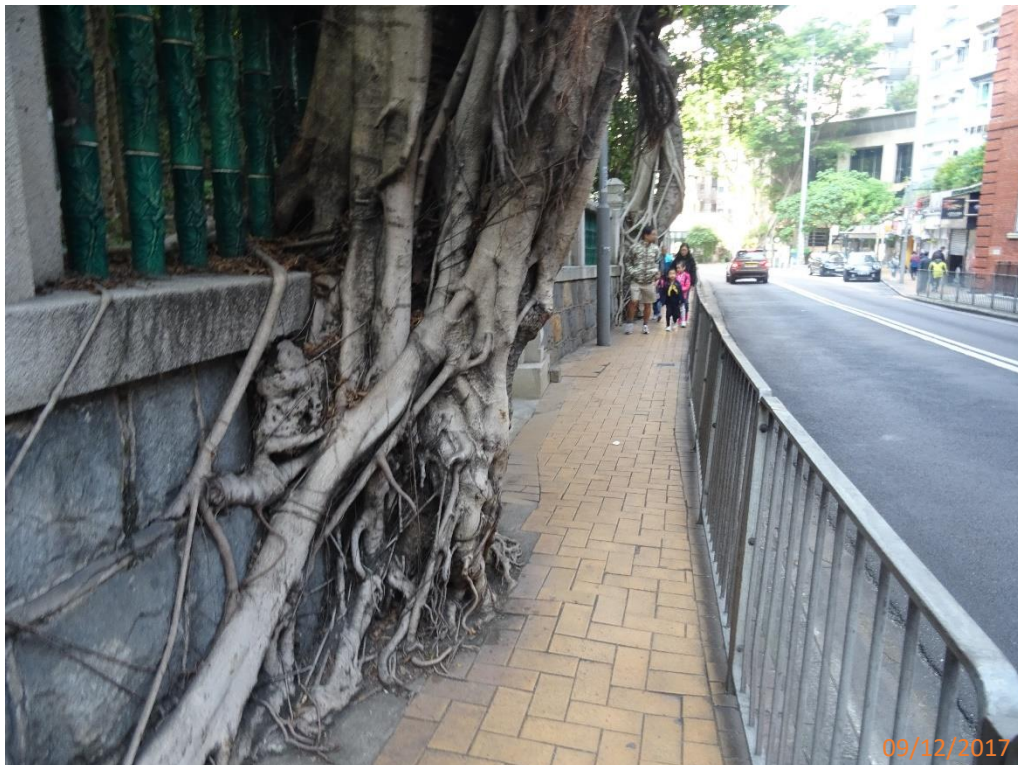
Root Condition: Root flare not visible and highly restricted by the pavement

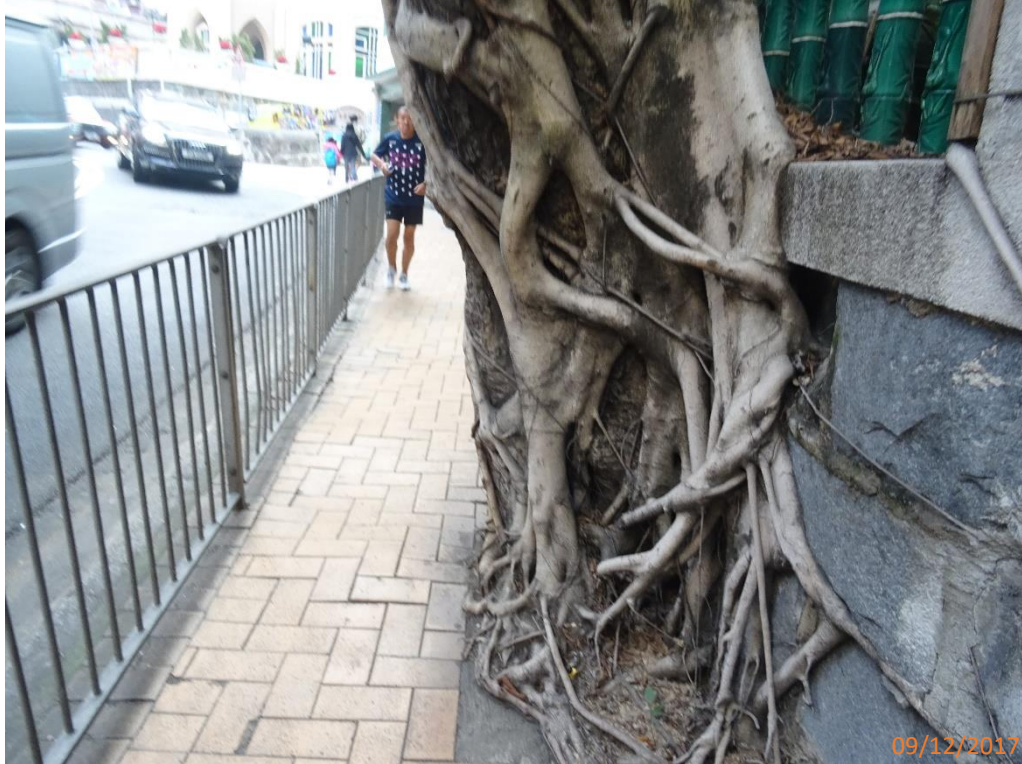
Root Condition: Exposed root

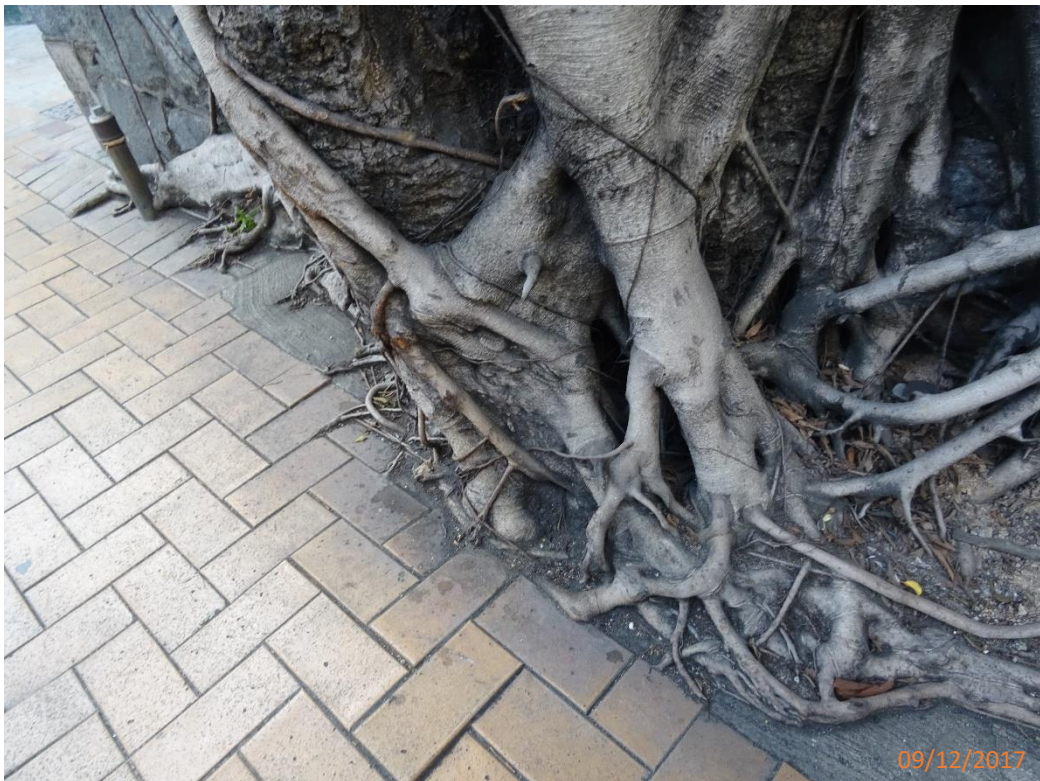
Root Condition: Girdling root

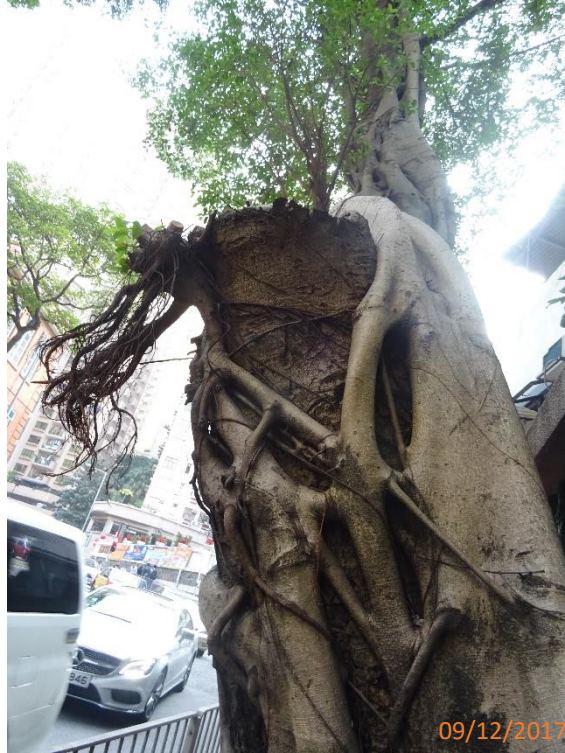
Root Condition: Cut/pruned aerial root

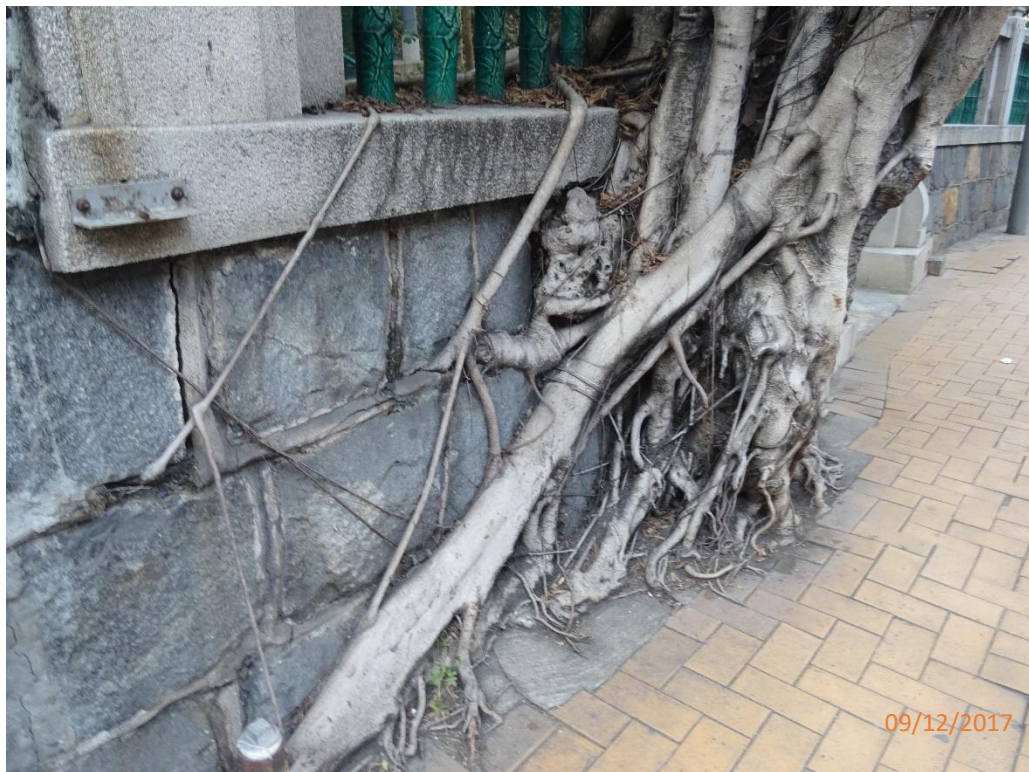
Cracks on the retaining structure

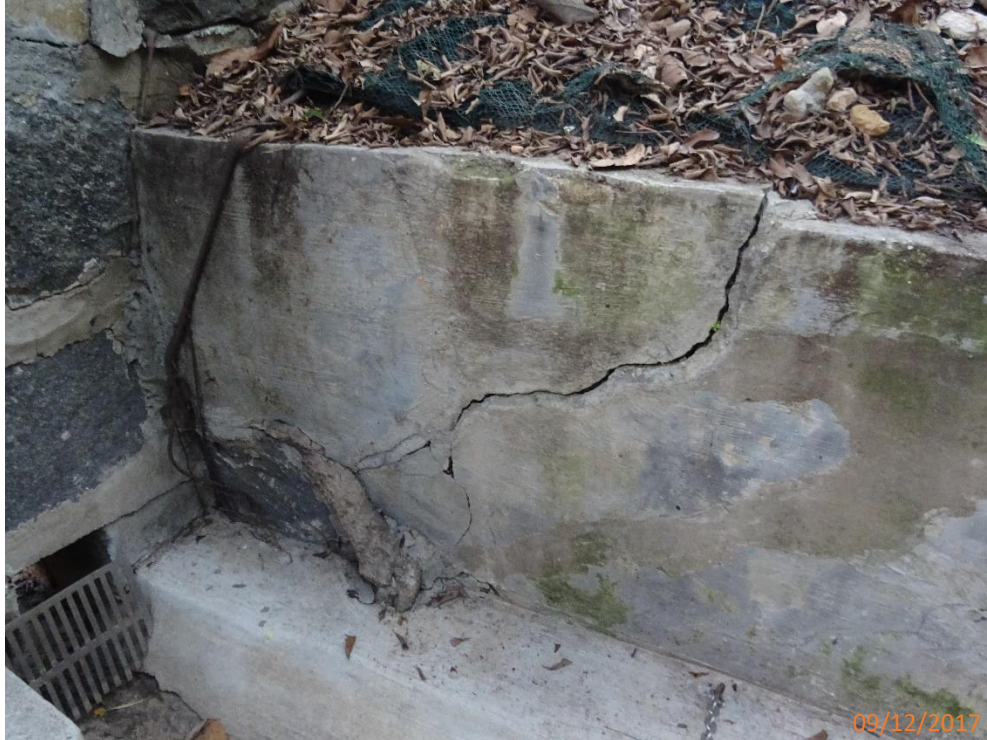
Cracks on the planter behind the tree

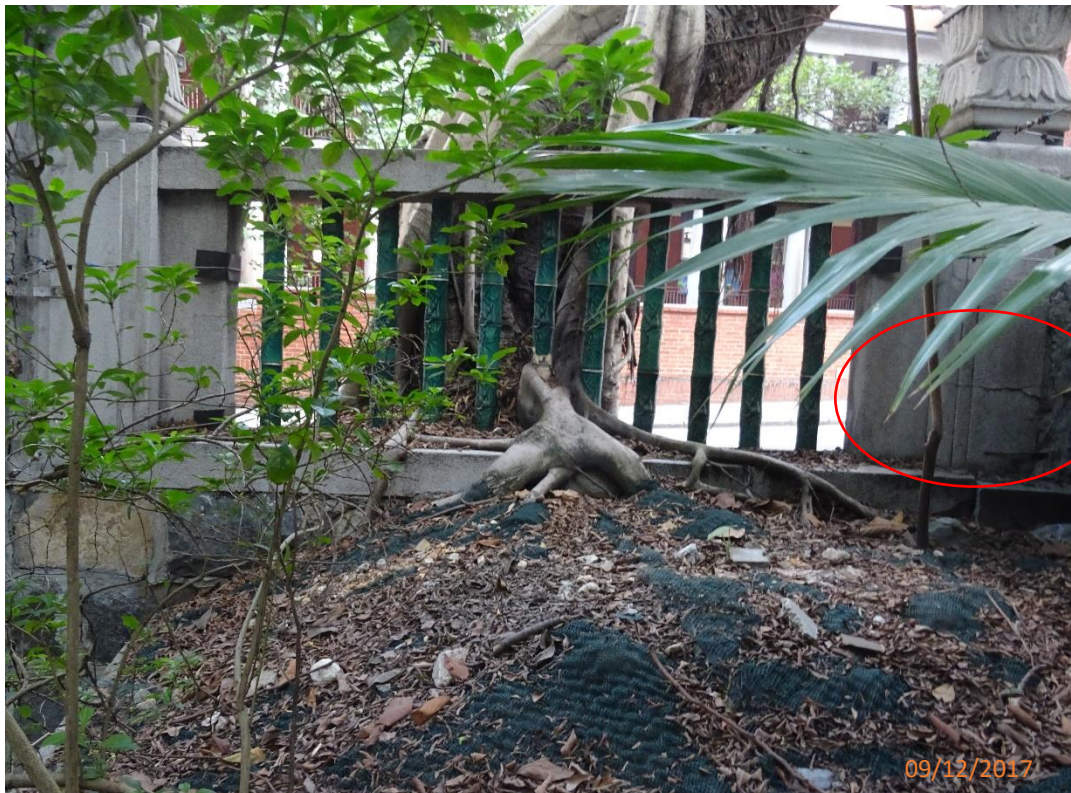
Tension side of the tree anchor into the slope planter. Cracks on retaining wall.

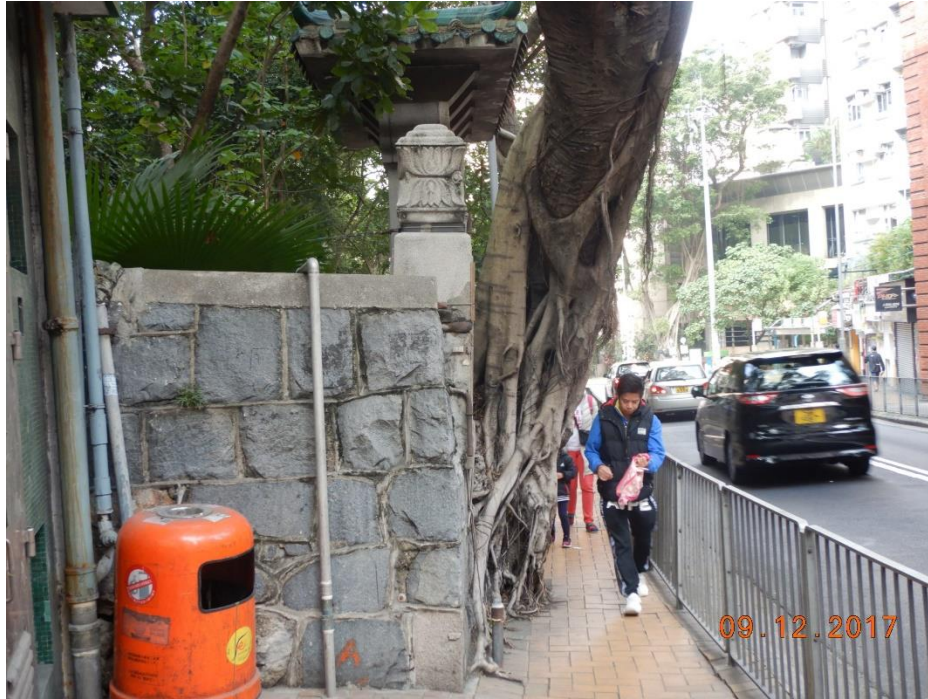
The trunk tends to grow and expand towards the pavement which conflict with the pedestrians use.

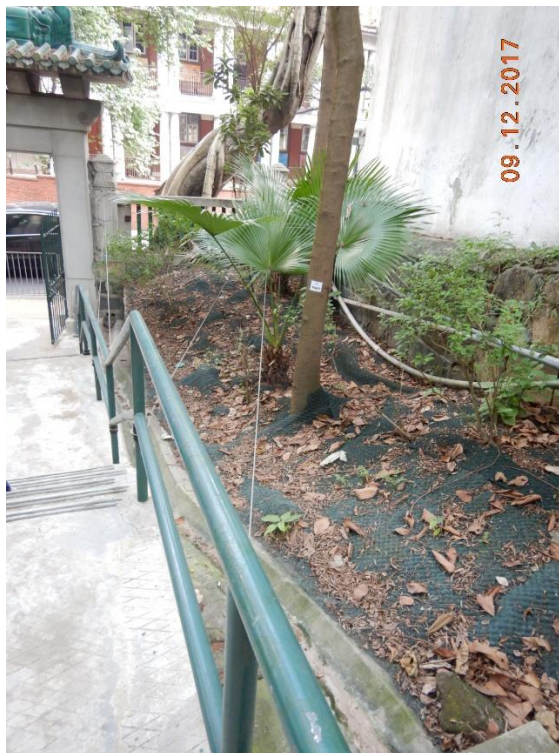
Existing cables system without enough tension

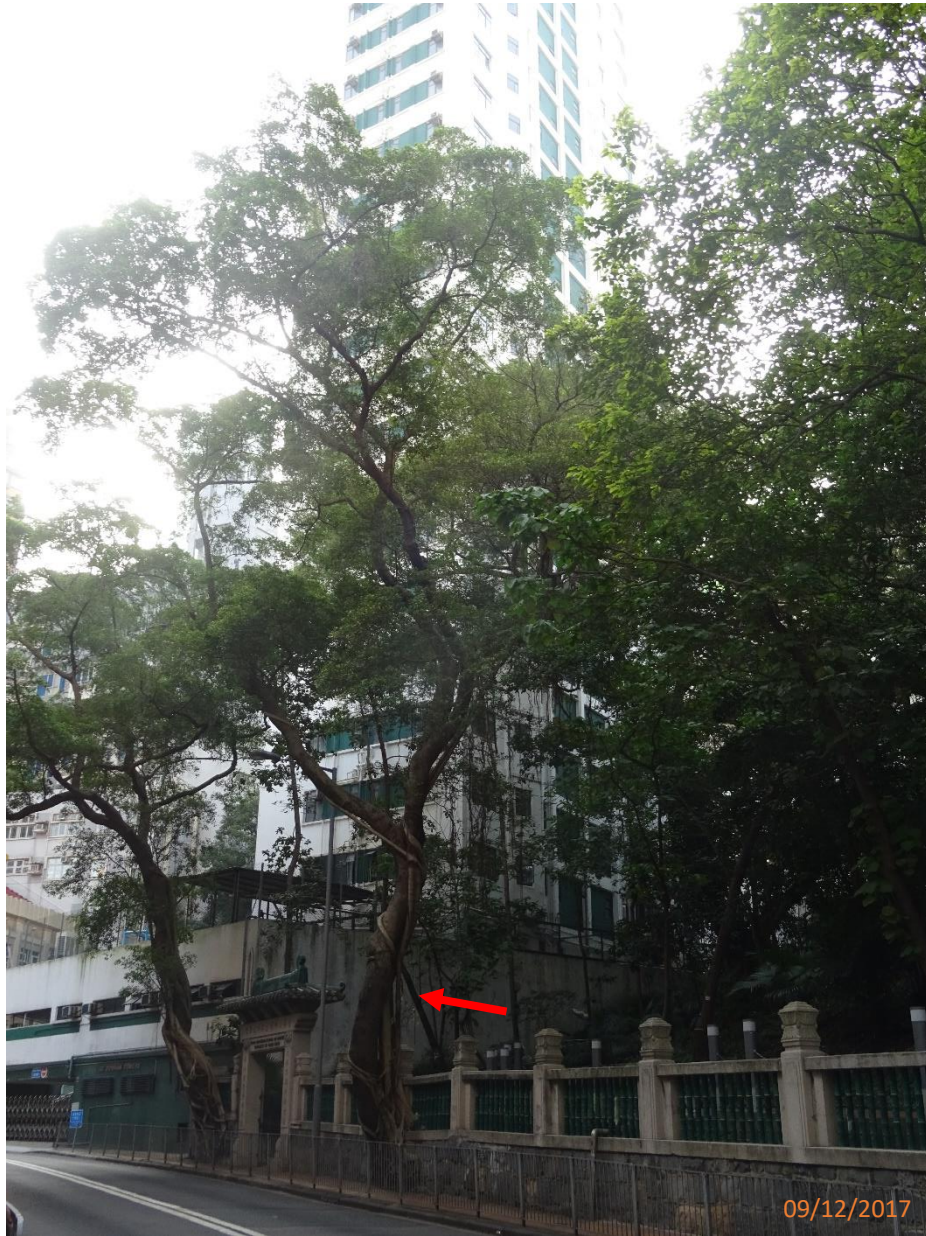
T2 *Ficus microcarpa* 細葉榕

At the time of inspection, T2 had fair to poor health since sparse foliage density was observed. Structurally, the tree was leaning at about 15 degree with unstable root-plate towards Bonham Road and the tendency of trunk growth was conflicting with the pedestrains. Restricted by the pavement, retaining structure and footing/railings, the rooting conditions were very unfavorable. Fugal fruiting bodies were observed at the roots. The tree was structurally weak. The root sprea on mansory wall was surface attachemnt only and with unknown amount of root penetration to the slope behind. The surface area of the retaining wall for tree anchorage was small and therefore, the wall may also fails when T2 fails or vice versa (overall failure). The mode of failure will be similar to the one failed at slope no. 11SW-A/R577 at Bonham Road on 22 July 2015. Severe cracks were observed on the retaining structures which may be caused by the root-plate movements of the T2. In the short term additional structural support such as cabling and wiring, metallic framework are highly recommended to stablize the tree. However, there are site constraint of limited space for additional structural support at the slope side. In the long term, the failure potential of T2 is high due to its weak structure which pose risk to the buildings, traffic and the pedestrians and thus, tree removal is recommended.

Overview of T2: Leaning at about 15 degree towards the Bonham Road

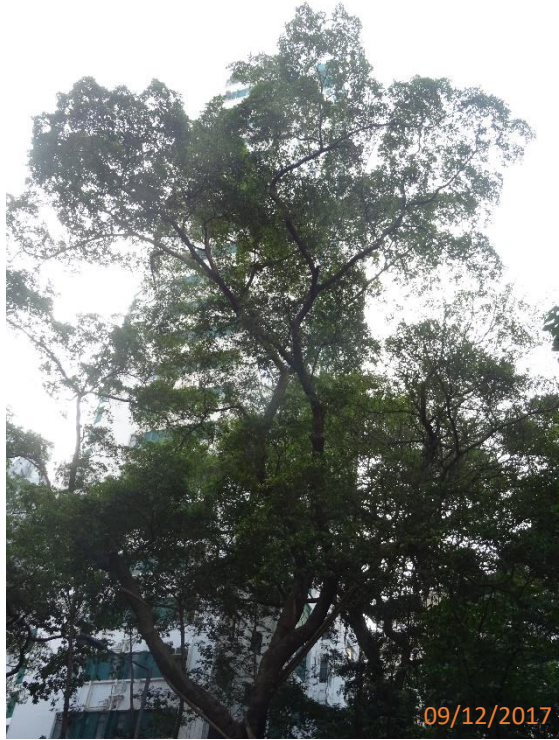
Crown Condition: Sparse foliage density; Crown reduced before

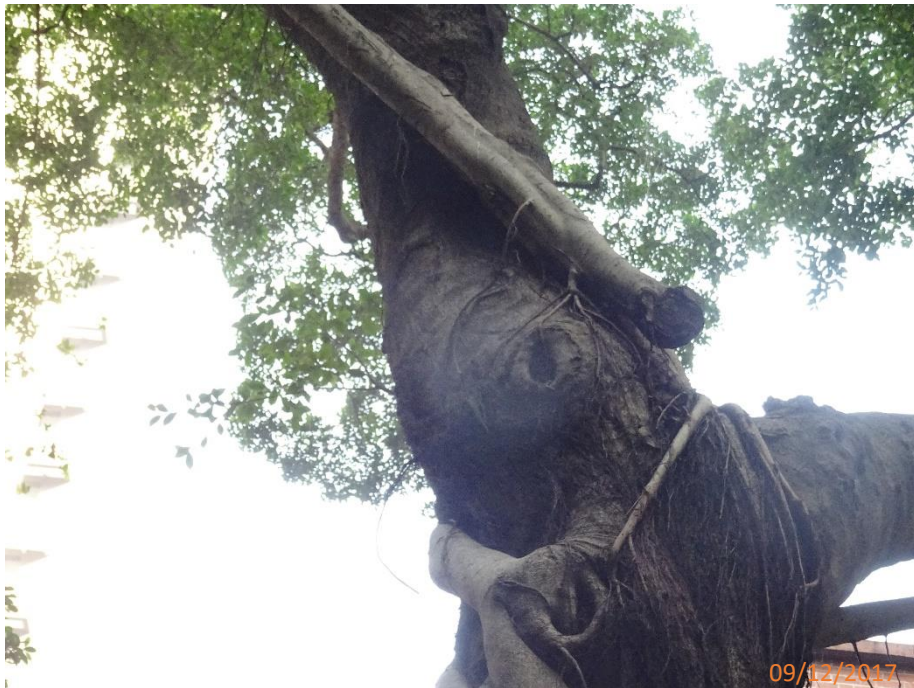
Branch Condition: Wounds

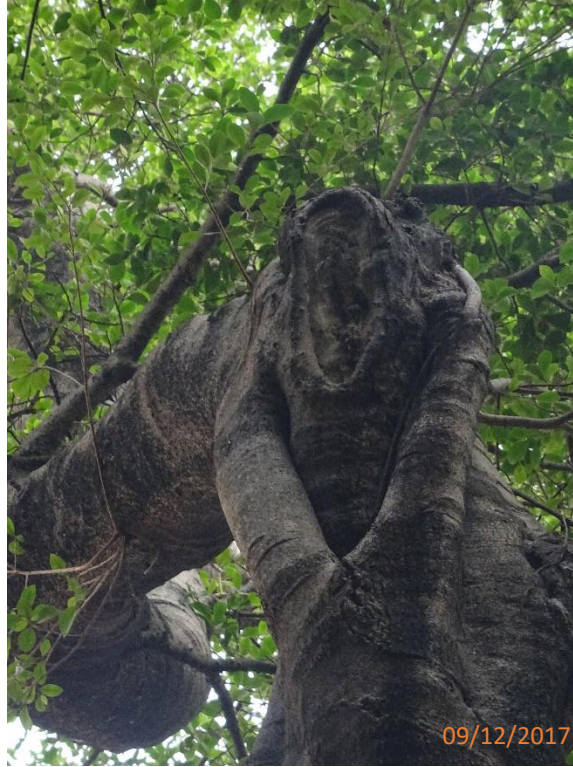
Branch Condition: Wounds

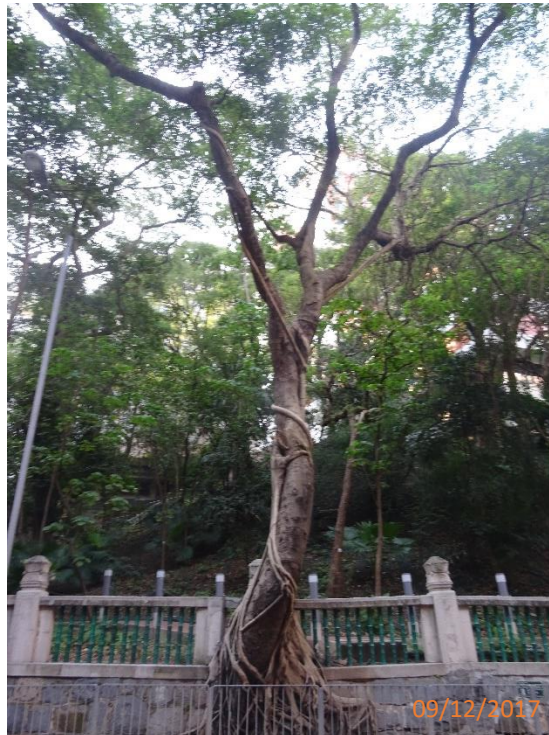
Overview of trunk condition

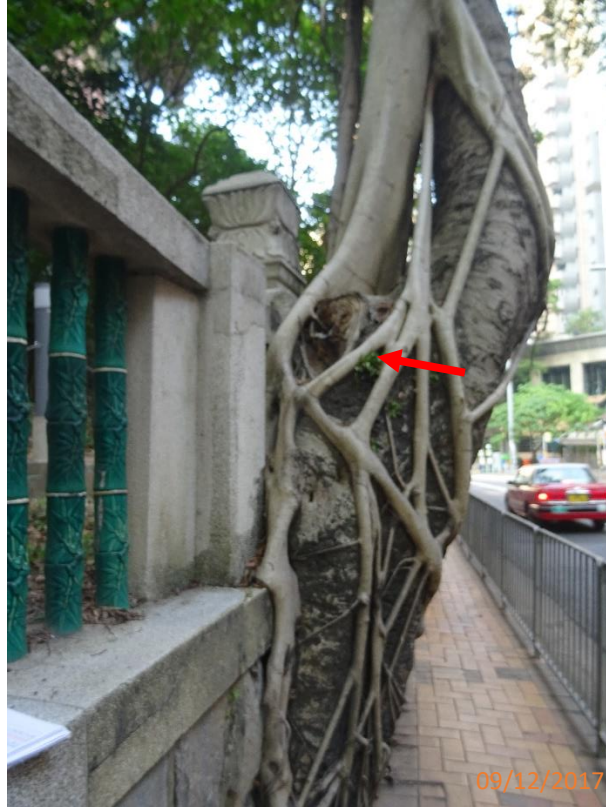
Trunk Condition: Cavity

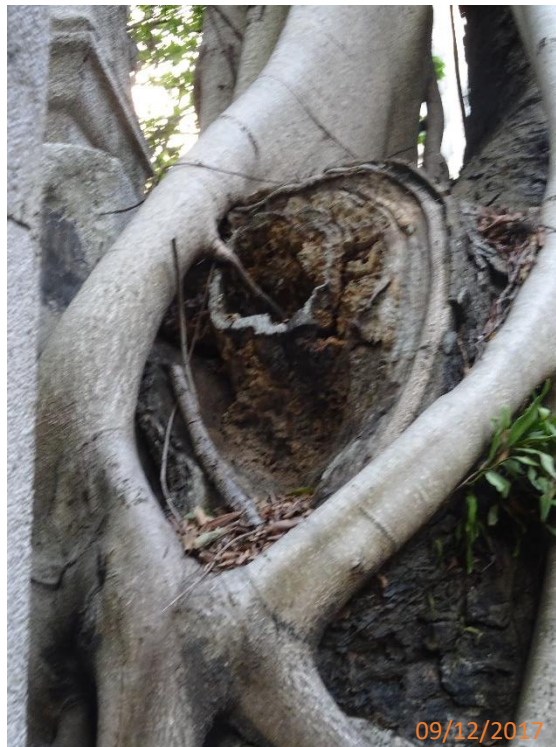
Trunk Condition: Close up of cavity 500mm length, 300mm length, 200mm depth

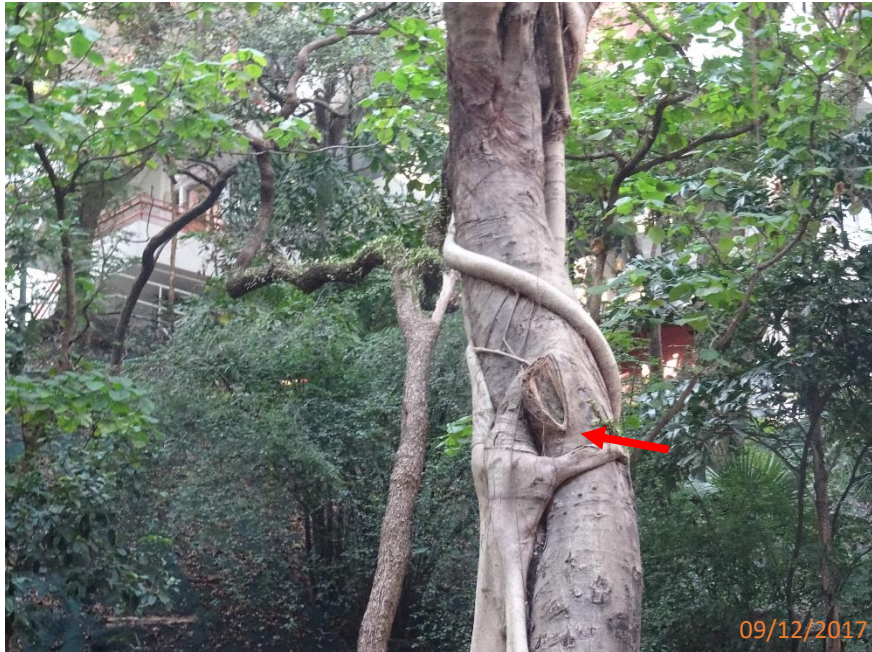
Trunk Condition: Wound

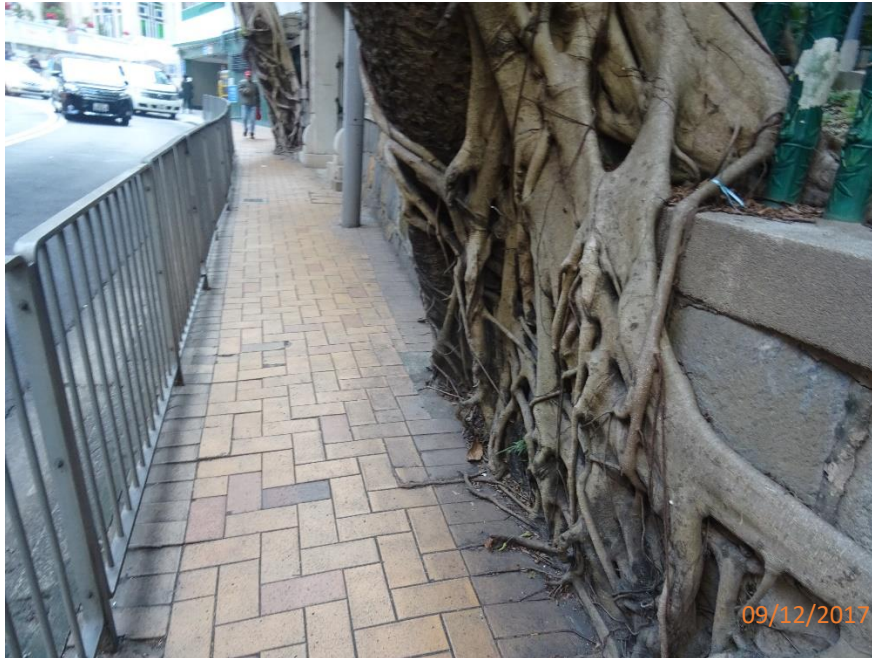
Root Condition: Root flare not visible and highly restricted by the pavement

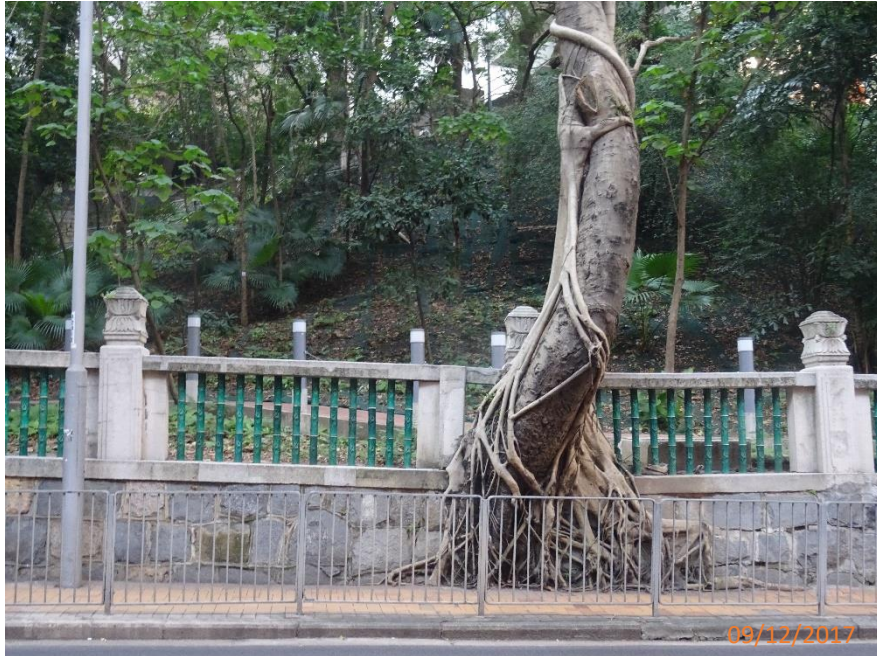
Root Condition: Exposed root

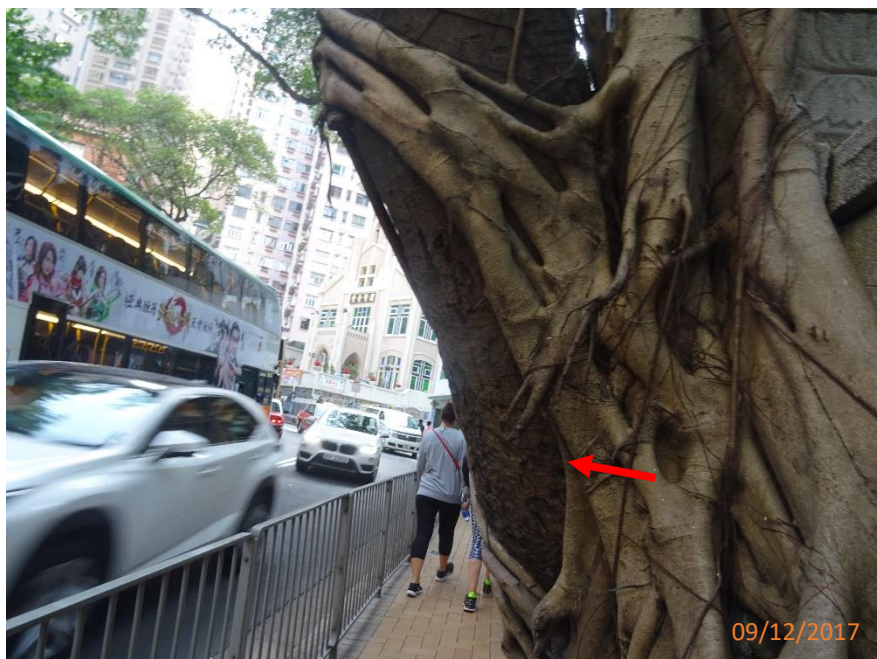
Root Condition: Root flare not visible and highly restricted by the pavement

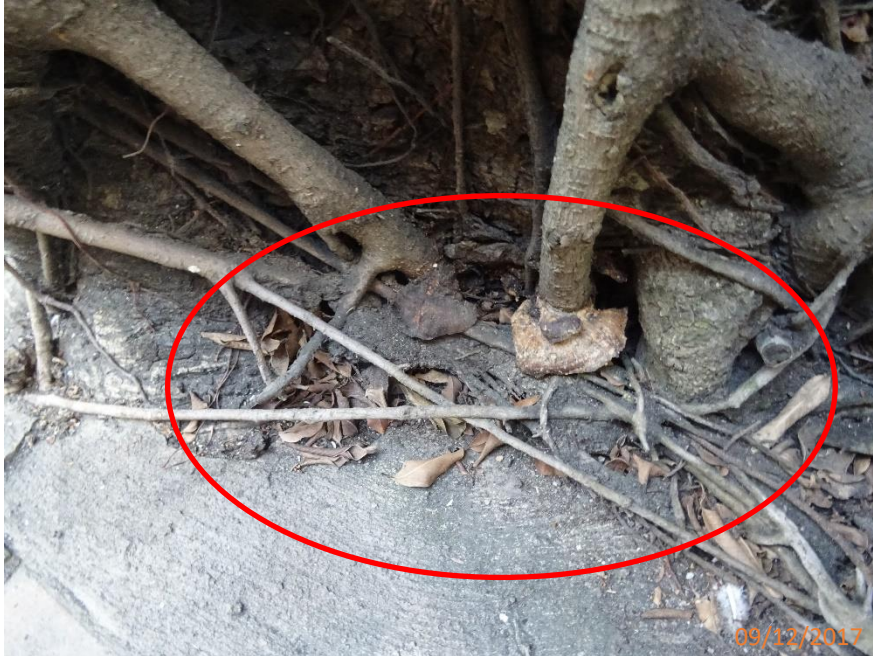
Root Condition: Fungal fruiting bodies

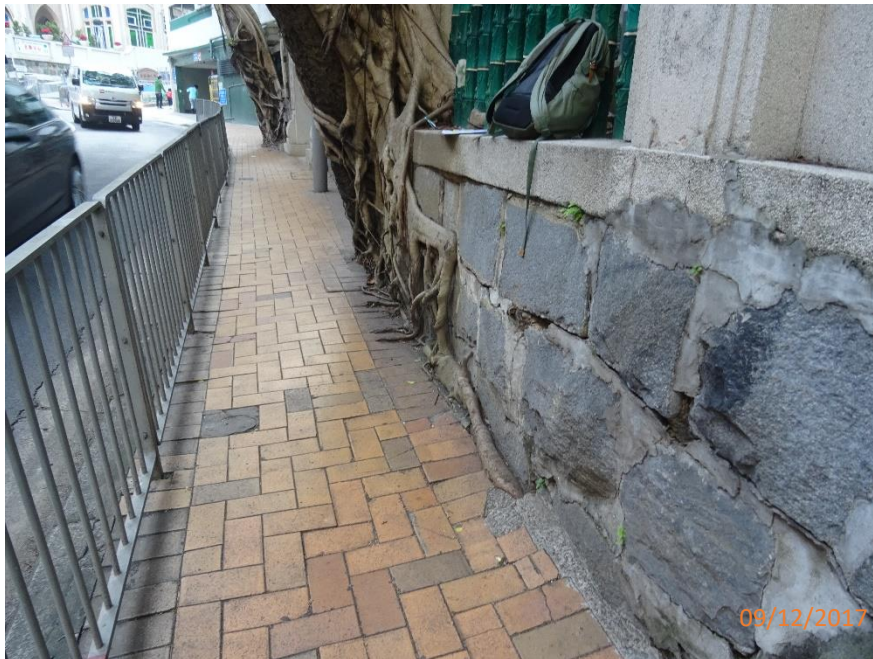
Severe cracks on the retaining structure

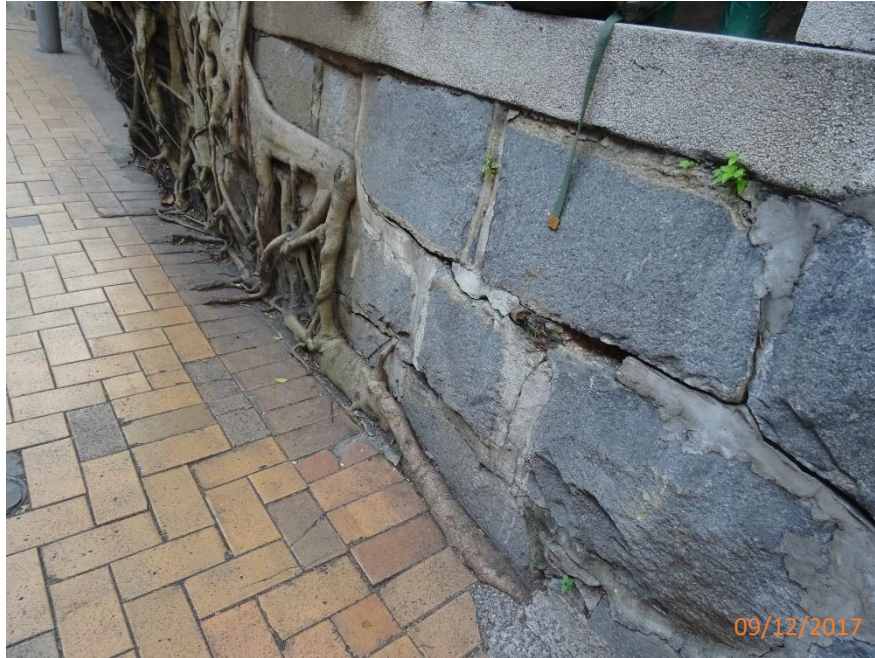
Close-up of the cracks

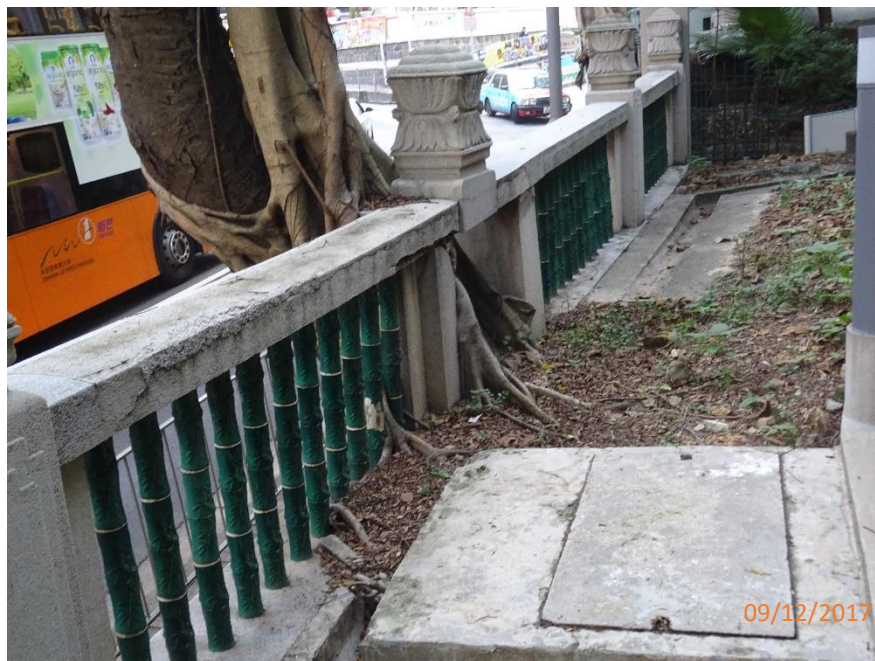
Tension side of the tree anchor into the slope planter. Cracks on retaining wall.

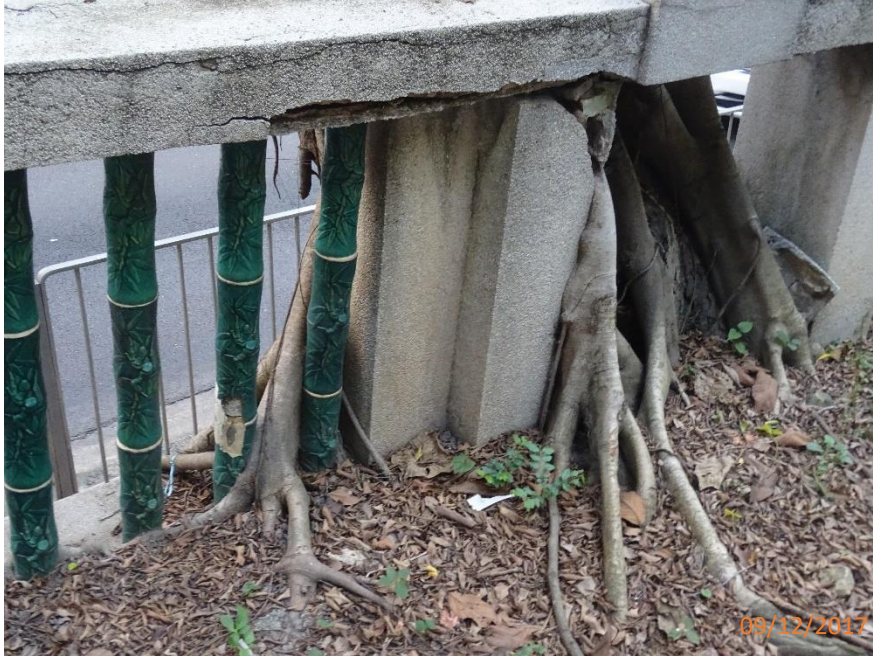
Close-up of the cracks
