**地政總署**  
**建議移除位於般咸道**  
**香港大學鄧志昂樓前兩株大樹**

## 附件二

## Tree Risk Assessment Form 2 - Individual Tree

## T1 Form 2 Photo Record

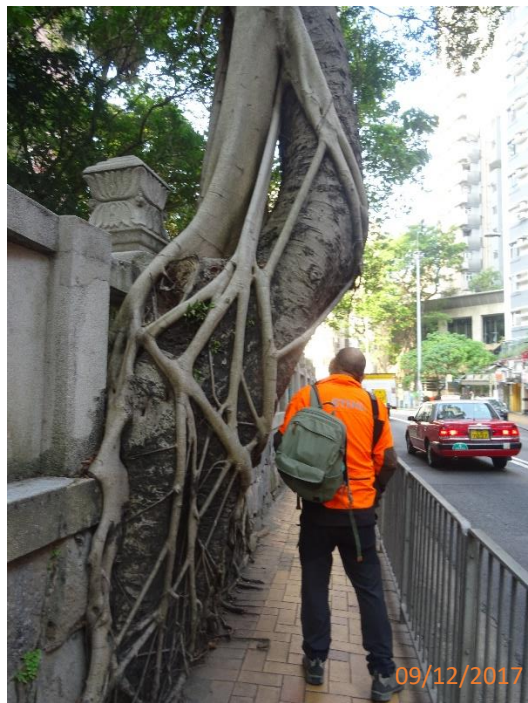
The trunk tends to grow and expand towards the pavement which conflict with the pedestrian use.
