Shaukiwan Road

Stanley Road

Pok Fu Lam Conduit

22 masonry bridges and aqueducts, 4 drainage culverts

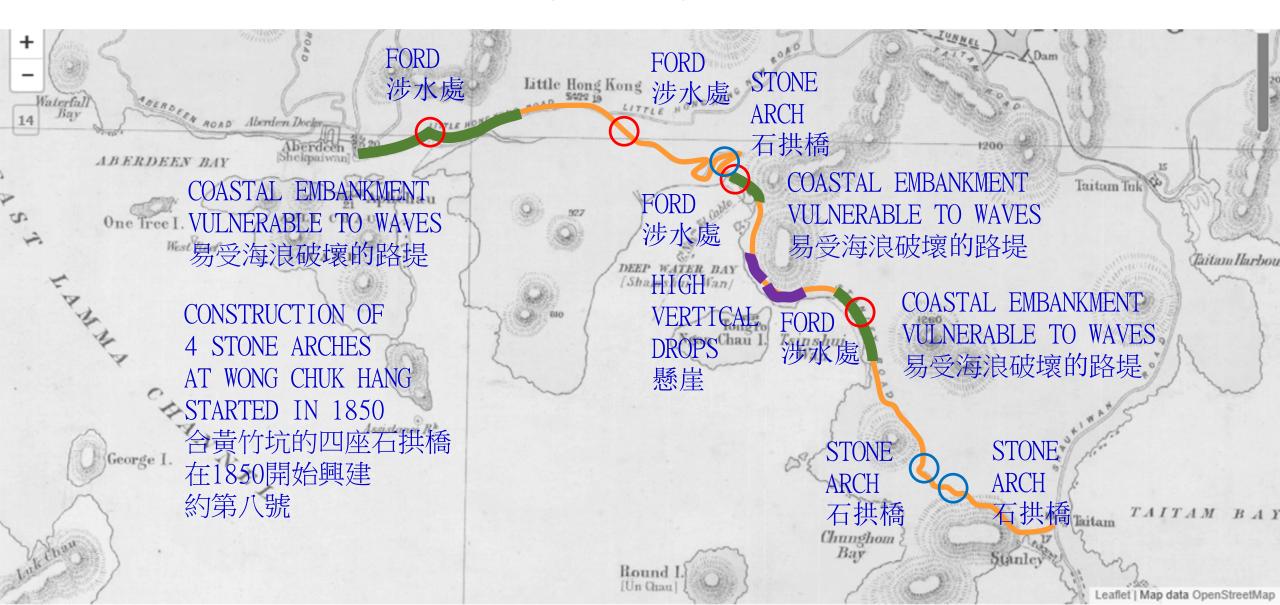
2021 Stanley Road

Red line: Stanley Road built in 1847-48 is overgrown but identifiable and safe for pedestrian use. Vegetation to be cleared and path improved. Reconfirm and sign post the street name. Reserve alignment of future connection to public roads on east upon redevelopment of Ma Hang Prison.

Red circles: Two masonry bridges and drainage channels are among the remaining features built in 1848. Monument status for remaining features of Stanley Road and re-use as a pedestrian path. (DevB, AMO/AAB)

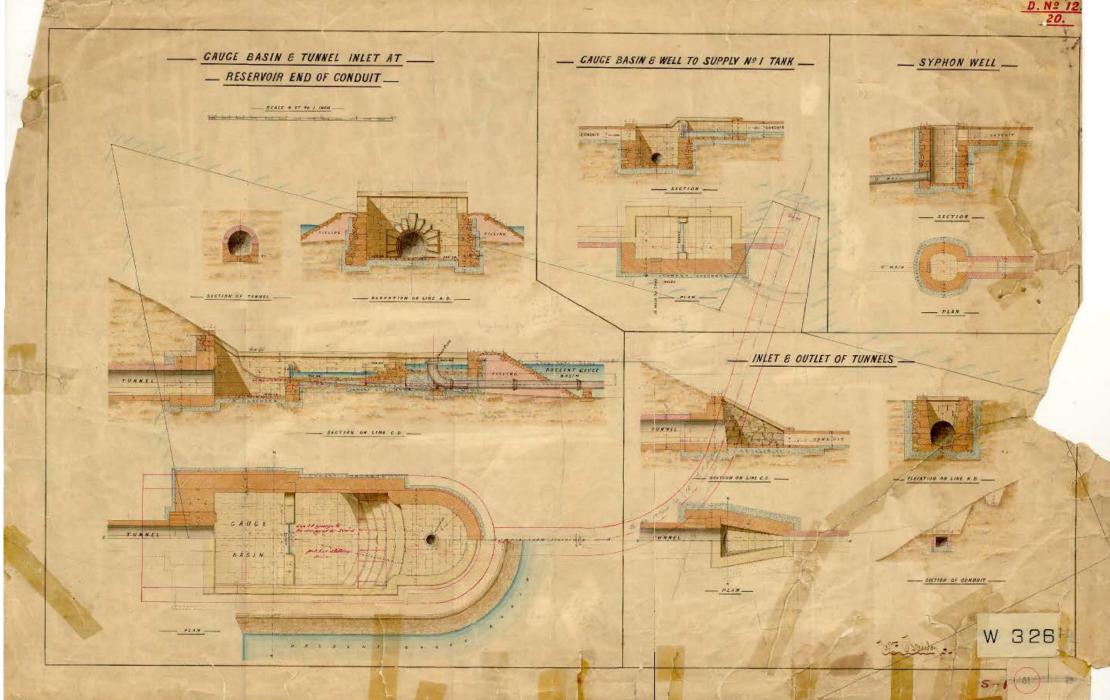
The Pok Fu Lam Conduit included 32 aqueducts between Pokfulam Reservoir and the West Point filter beds (near what is now known as the Lung Fu Shan Environmental Education Centre). A recent survey shows that 16 are still in tact. Number 9 is graded as a heritage structure.
