120 Wellington Street, Former Wing Woo Grocery Shop

A Historic Building Appraisal and Recommendations

Prepared by Jack Chui, HKICON, 1st December 2016

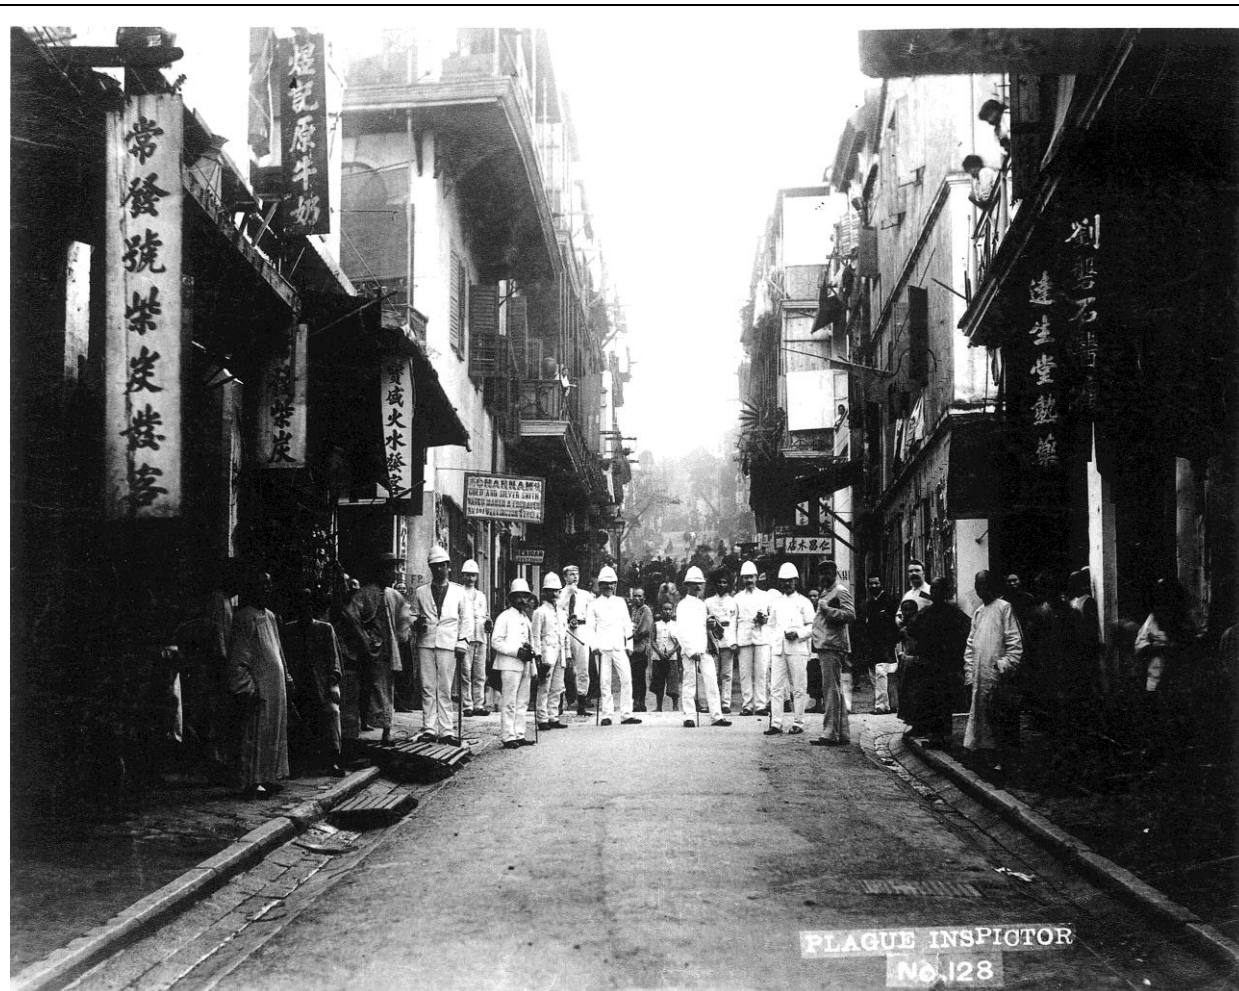
(Fig.4) Photograph dated 1894 showing the plague inspector inspecting the hygiene condition, the background being the junction of Wellington Street and Graham Street, note the Chan Nam Gold and Silver Smith signboard

1) There is a historic photo, taken in 1894 during the plague (see fig. 4), showing the hygiene inspector inspecting the hygiene condition on Graham Street. 120 Wellington Street is in the background with the signboard "鎮南 Chan Nam Gold and Silver Smith", which matches the record of the address on the Valuation Table at the time. The building's appearance on the photo matches what it is standing today.

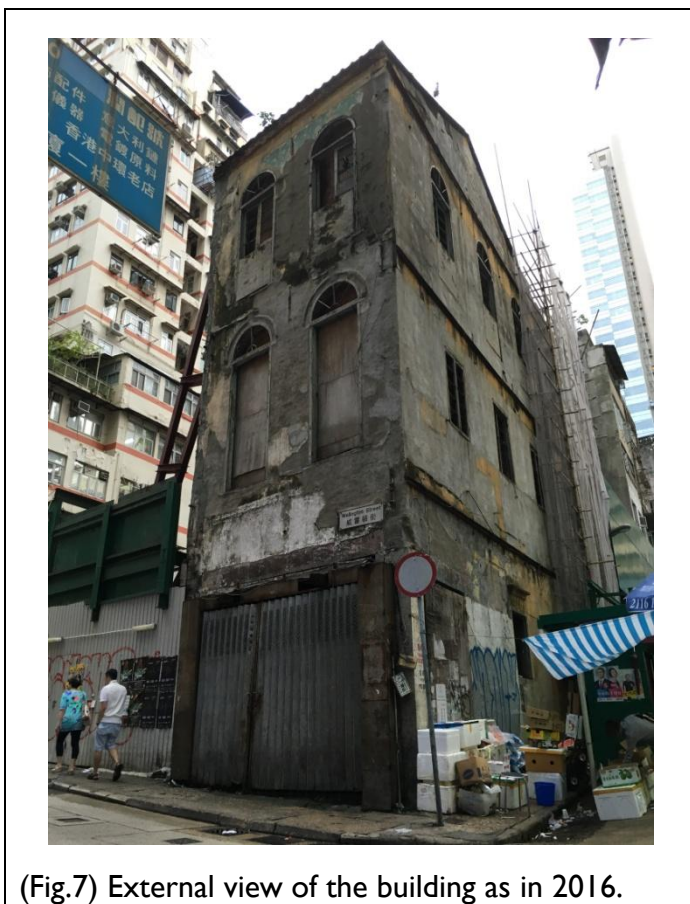
(Fig.7) External view of the building as in 2016.

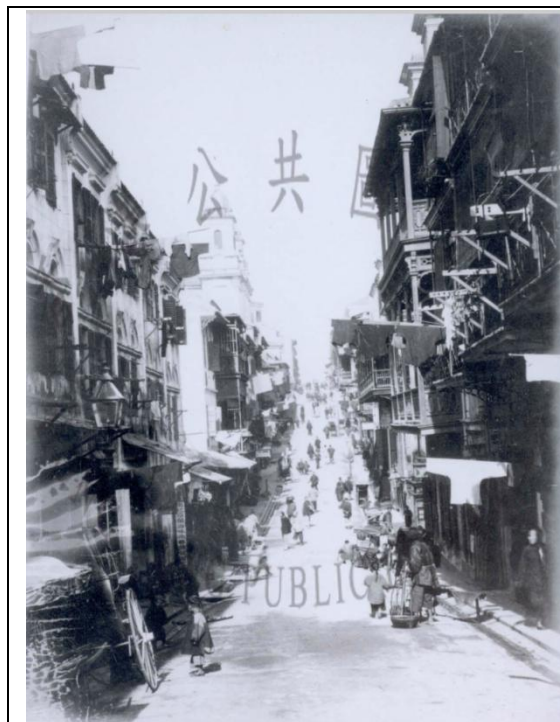
(Fig.9) Photograph taken on Wellington Street in 1880s, showing similar architectural details. (Source: Hong Kong Public Library)

2) There is a historic photo, taken in 1880 showing the general view of the Wellington Street (fig. 9). The building has similar architectural details with the buildings along the street: two-bay shop front with round arches and rendered moulding and keystones.

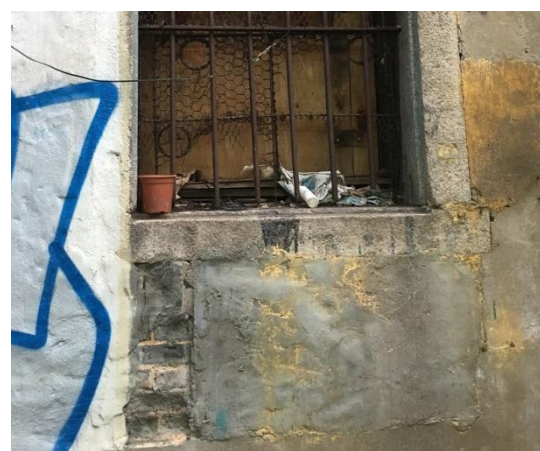
(Fig.10) Some of the green-grey brick revealed due to spalling render

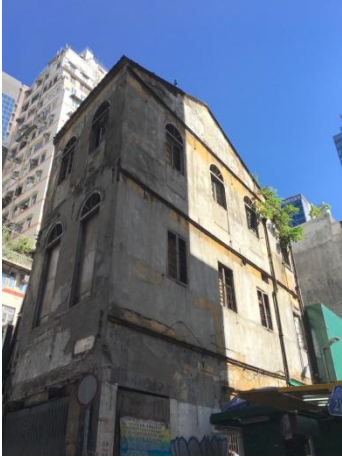
| Feature | Photo | Significance | Recommendation |
|---|---|---|---|
| Building façades (north elevation and west Elevation) | | High | Alteration to masonry walls should be limited to minimum. Infill redundant openings, Indentify any structural repairs required and carry out repairs. |

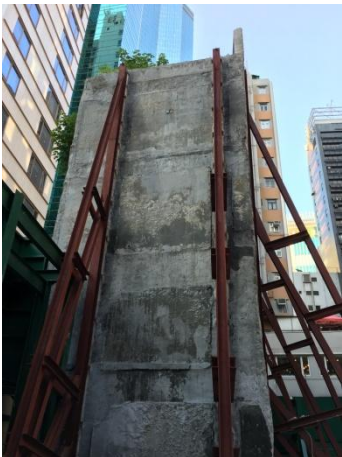
| Feature | Photo | Significance | Recommendation |
|---|---|---|---|
| Building façades (south elevation and east Elevation) | | Low | They used to be party walls. Openings can be formed for MoE requirements. |

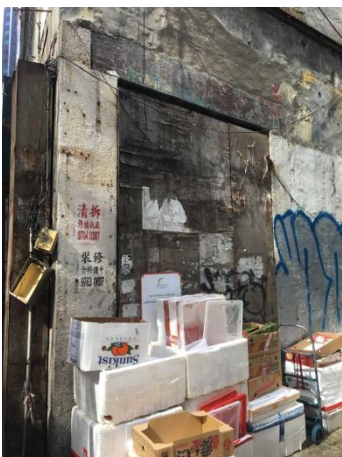
| Feature | Photo | Significance | Recommendation |
|---|---|---|---|
| Granite piers and timber beams shop front and verandah | | High | Remain in-situ. Remove graffiti and paint on granite. Fire retardant treatment to timber beam. |

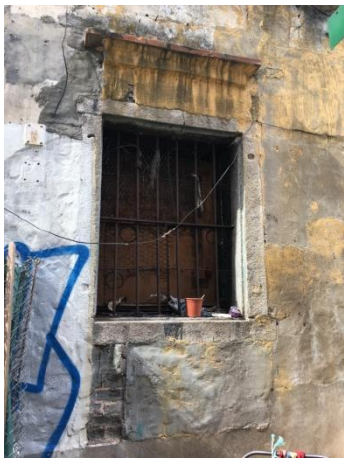
| Granite surround on ground floor window | | Medium | Remove paint and express granite surround. |

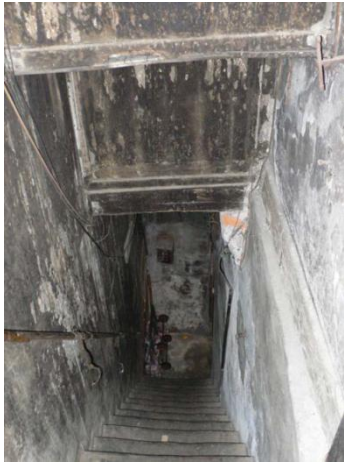
| Feature | Photo | Significance | Recommendation |
|--|---|---|--|
| Timber staircase and timber panel walls | | High | Check termites. Repair/replace using like for like materials as necessary. |

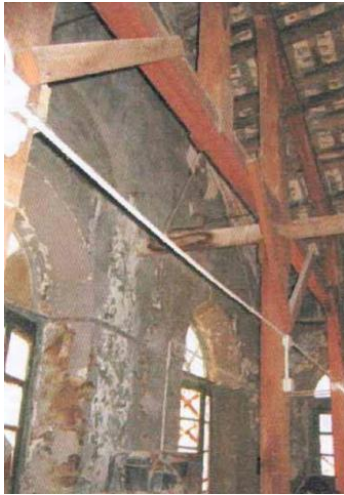
| Feature | Photo | Significance | Recommendation |
|--|---|---|--|
| Roof timber | | High | Check termites. Repair/replace using like for like materials as necessary. |
