**Assessment Report on  
Feasibility of Tree Support Systems proposed in  
Study on Stonewall Trees on Slope no. 11SW-A/R577  
Bonham Road, Hong Kong**

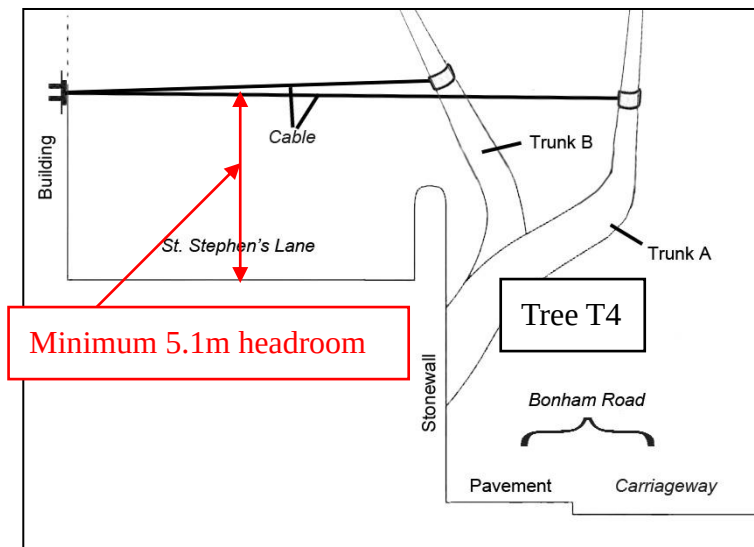
Sketch 2.1

#### 2.3.1 Method A is considered infeasible for the following reasons:

- (ii) Even if agreement can be obtained from the owners, the anchorage of the proposed cable bracing system will have to be provided at the facade of the common podium of the nearby Golden Phoenix Building to avoid potential structural and visual impact to individual residential units. With this cable supporting system, large tension force (in the order of 30 tonnes for T4 and 4 tonnes for T5) will then be induced in the cables to support or stabilise the tree due to the dead weight of the tree and wind loads acting on the tree. There can be detrimental damage to the adjacent buildings and severe injury to the public caused by the immense destructive force from the failure of trees/branches/cables and associated parts during typhoon or strong gust/monsoon wind. It is estimated that two anchorage plates of 550mm x 550 mm size with four 24mm diameter high tensile strength bolts anchoring 210mm in the building are required (with at least 270mm thick concrete being required to hold the bolts). However, as the building is quite old, the condition of concrete is uncertain. Moreover, the estimated wall thickness is only 250mm (Photo 2.3). Therefore the suitability of the anchorage is in doubt. The anchorage depth of 210mm

would also affect the existing reinforcements inside structural members of the building.

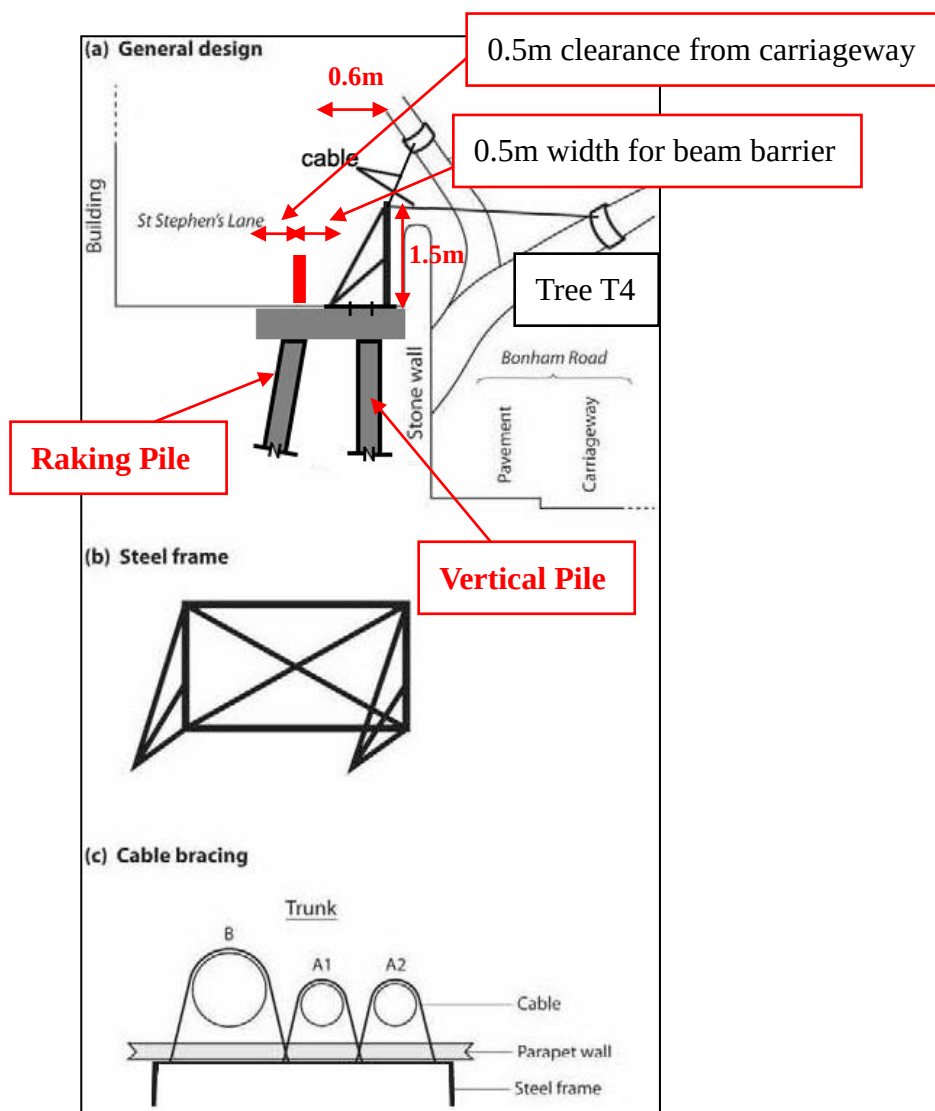
Sketch 2.2

#### 2.4.1 Method B is considered infeasible for the following reasons:

- (i) St. Stephen's Lane is a one-lane two-way carriageway of about 4.5m width, being shared use with pedestrians. The existing road width is not up to current standard due to site constraints. The road width at the location of Tree T4 and T5 are 4.25m and 4.50m respectively. As the absolute minimum carriageway width requirement for a single track access road serving as emergency access<sup>2</sup> is 3.5m and the horizontal clearance requirements for carriageway to building/structure/obstruction<sup>3</sup> is 0.5m on each side, the existing road width is already below or at the minimum standard. It is not viable to install any structures at St. Stephen's Lane due to the road width constraint. (Photo 2.4)

- (iv) To avoid transferring extra loading to the crest of the stonewall, the foundation of the steel frame for supporting the tree has been preliminarily assessed to take the form of seven mini-piles (three vertical and four raking piles) at St. Stephen's Lane in order to tie the steel frame firmly onto the ground. The vertical piles would certainly hit the masonry blocks behind the stonewall. To resist the estimated lateral and pulling force, the raking piles would also extend across the lane and encroach into the building lot boundary, hitting the building foundation. The scheme is therefore considered infeasible. Moreover, the tree roots growing under the St. Stephen's Lane behind the masonry wall will be damaged

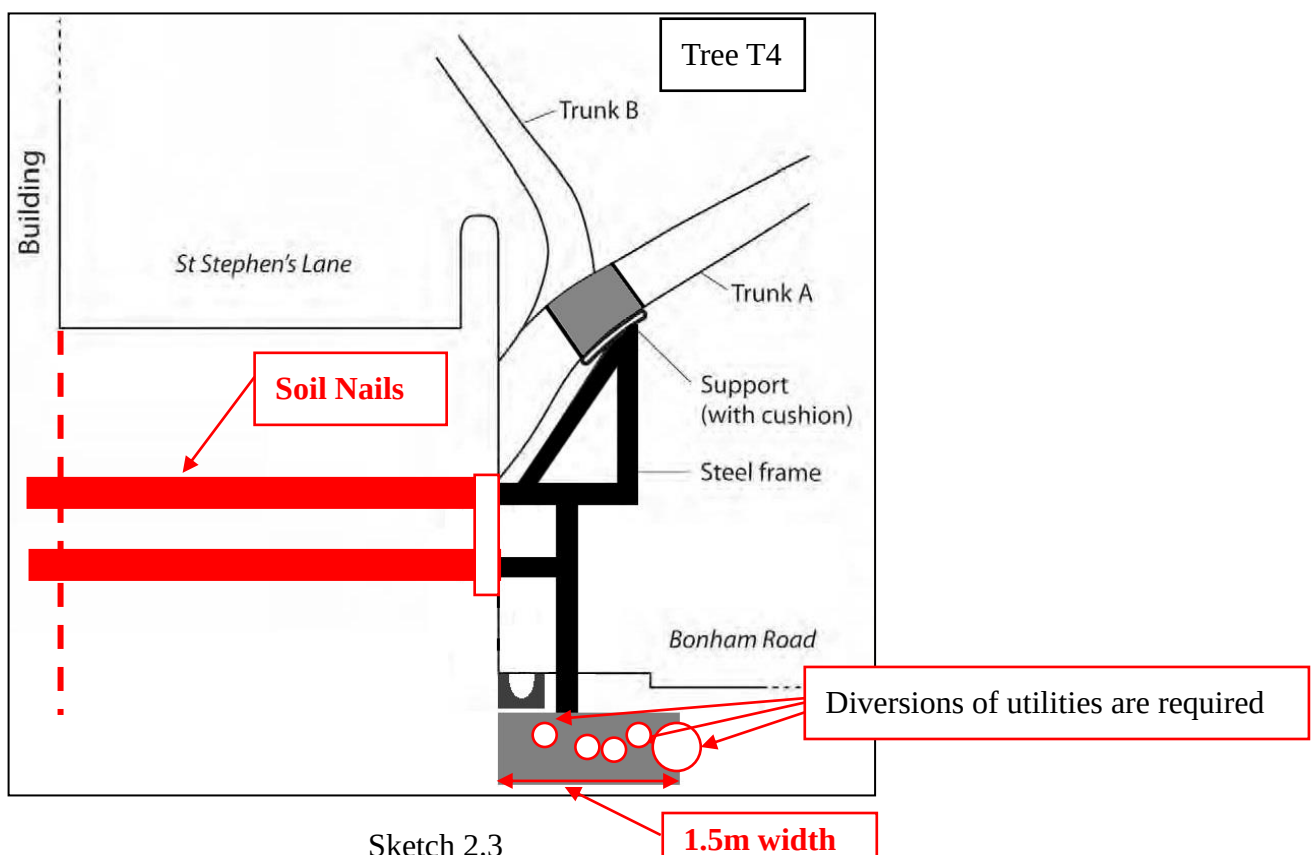
2.5.1 Method C is considered infeasible for the following reasons:

- (i) From our survey, the lower part of the tree is only 2.5m above the existing footpath at Bonham Road. The estimated size of the supporting beams is 0.3m in depth. As such, minimum headroom of 2.3m for footpath cannot be maintained if the supporting frame is to be constructed on the masonry wall adjacent to the footpath. (Photo 2.5)

- (ii) Similar to Method B, the proposed structure (steel frame) will induce extra loading and overturning moment onto the stonewall. To provide the restoring force, installation of two layers of soil nails with 6m long under and across St. Stephen Lane is required. However, the soil nails will hit the foundation of the nearby building and is therefore impractical. Diversion for underground electric cables at St. Stephen Lane, which are expected to be buried at depth greater than 900mm, may also be required. (See also Method B, para. 2.4.1 (iii) and (v).)

- (iii) In addition, the supporting frame will have to stand on the narrow southern footpath of Bonham Road with a foundation of about 1.5m x 1.5m in size. According to the utility records, there are underground utilities such as drainage pipes, electricity cables, gas pipes located at the section of the footpath. Underground utilities also exist at the opposite footpath so that the space available to accommodate utilities diverted from the southern footpath is limited. Underground utilities diversion to provide space for the supporting frame will result in closure of traffic lane at Bonham Road for a long period and will cause serious traffic disruption.

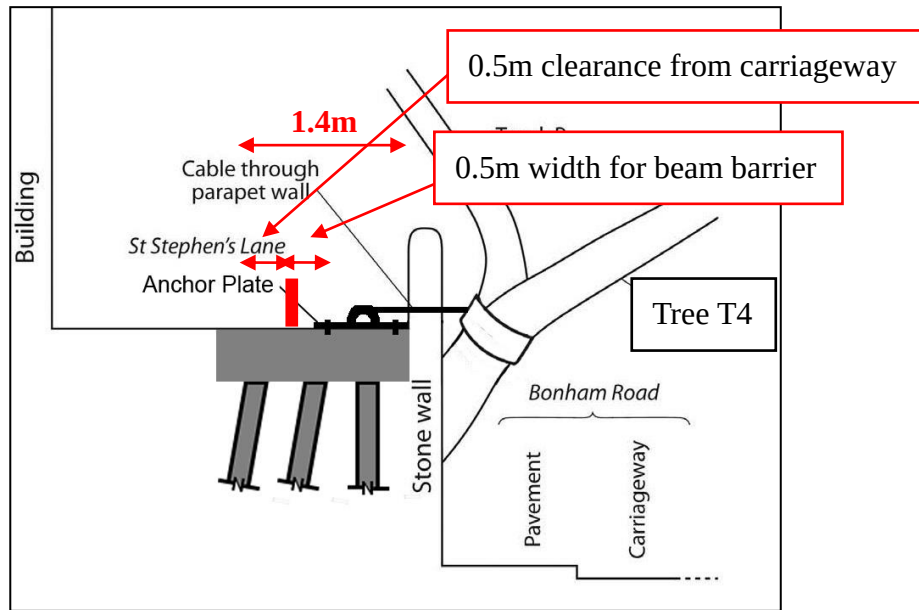
Sketch 2.4

### 2.6.1 Method D is considered infeasible for the following reasons:

- (iii) Owing to low anchorage point, the overturning moment of the dead load and wind load of the stonewall tree will create a very large tension force on the cables (in the order of 260 tonnes for T4 and 42 tonnes for T5). The foundation of the structure would be in the form of eighteen mini-piles (twelve raking and six vertical piles) at St. Stephen's Lane to

provide the required lateral resistance. The raking piles would hit the foundation of the nearby building and make the scheme infeasible. (See also Method B, para. 2.4.1(iv).)

- (iv) In addition, diversion for underground electric cables at St. Stephen Lane is required. (See also Method B, para. 2.4.1(v).)

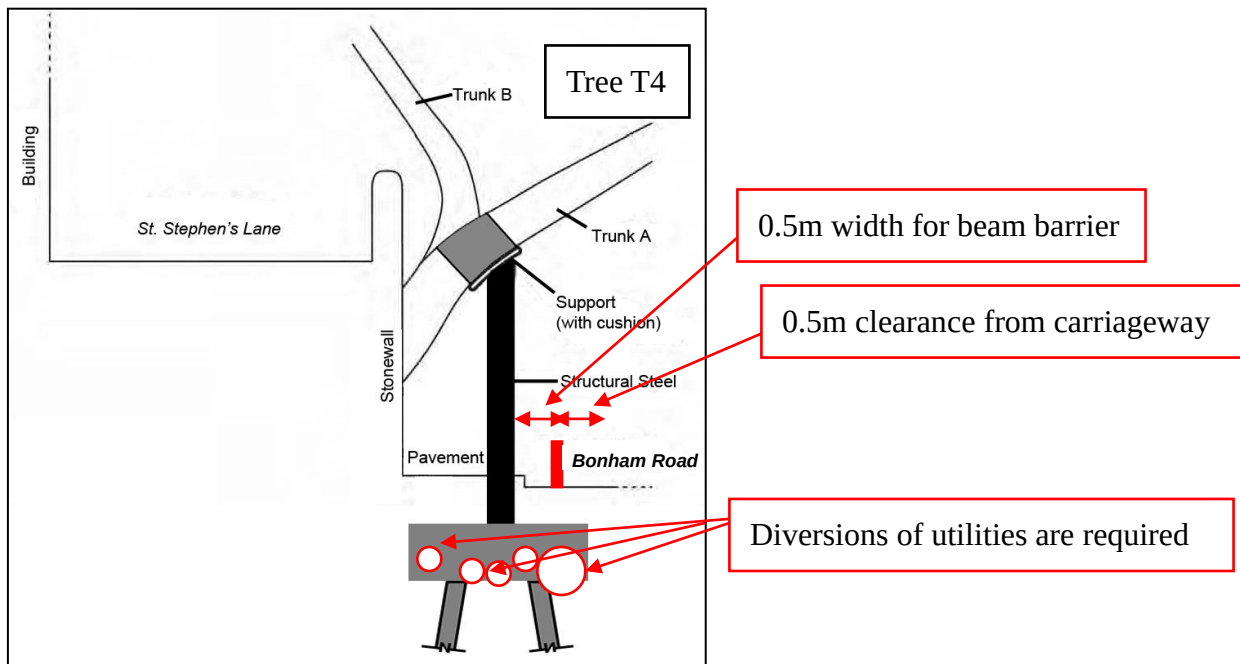
Sketch 2.5

2.7.1 This method is considered infeasible for the following reasons:

- (i) The existing footpath width near tree T4 and T5 is only 1.23m (Photo 2.6) which is not up to current standard. It is already too narrow to accommodate both pedestrians and passengers waiting at the bus stop. The construction of structures occupying extra footpath spaces is therefore impractical.

- (iii) Large supporting moment (in the order of 2300KNm for T4 and 360KNm for T5) to support or stabilise the trees by the steel pole and foundation is required to counterbalance the bending moment induced from the dead weight of the tree and wind loads acting on the tree. The foundation of the steel structure in the form of four raking mini-piles is required. The pile cap size will be in the size of 2.5m x 2.5m. Diversions of utilities at

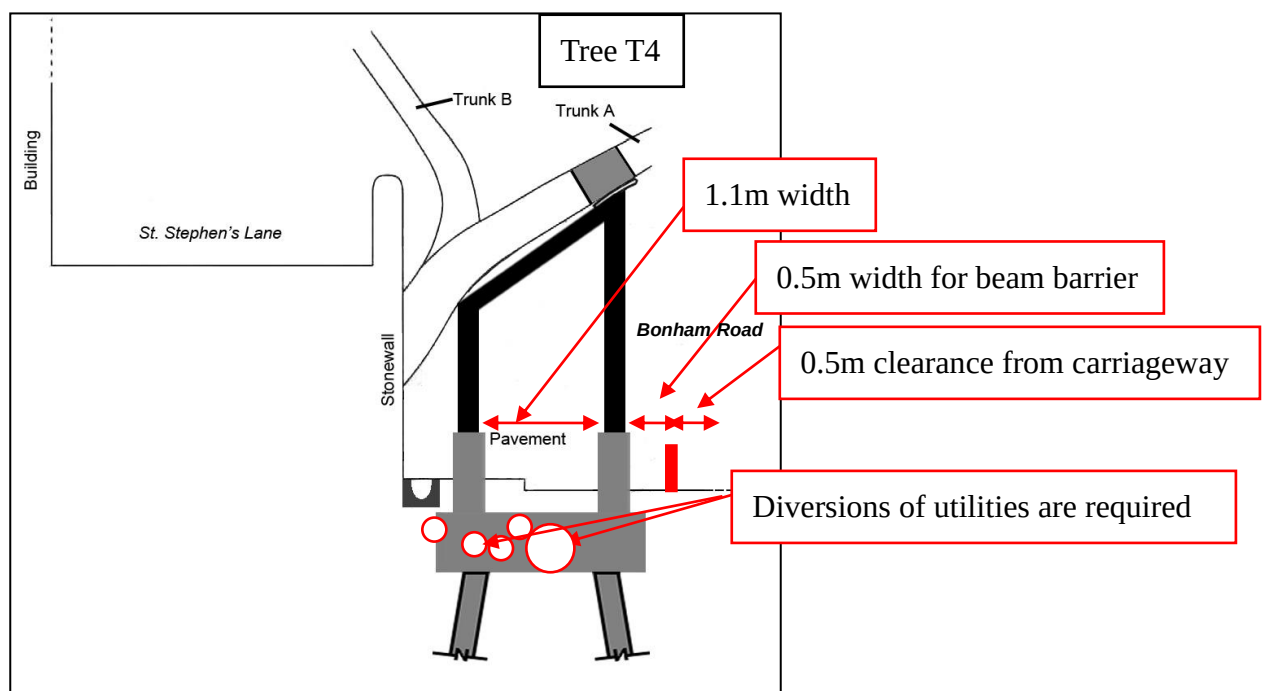
Sketch 2.6

2.8.1 This method is considered infeasible for the following reasons:

- (i) The existing footpath width near tree T4 and T5 is only 1.23m. (See also Method E, para. 2.7.1(i).)
- (ii) If the bus stop could be relocated, an additional road width of about 2.4m might be available. With the provision of beam barrier and 0.5m clearance from the carriageway, the remaining road width for pedestrians is only 1.1m (Sketch 2.6) at most which is undesirable. Most importantly, the relocation of the bus stop is impractical. (See also Method C, para. 2.5.1(iv).)
- (iii) Diversions of utilities at the southern footpath of Bonham Road are required. (See also Method C, para. 2.5.1(iii).)

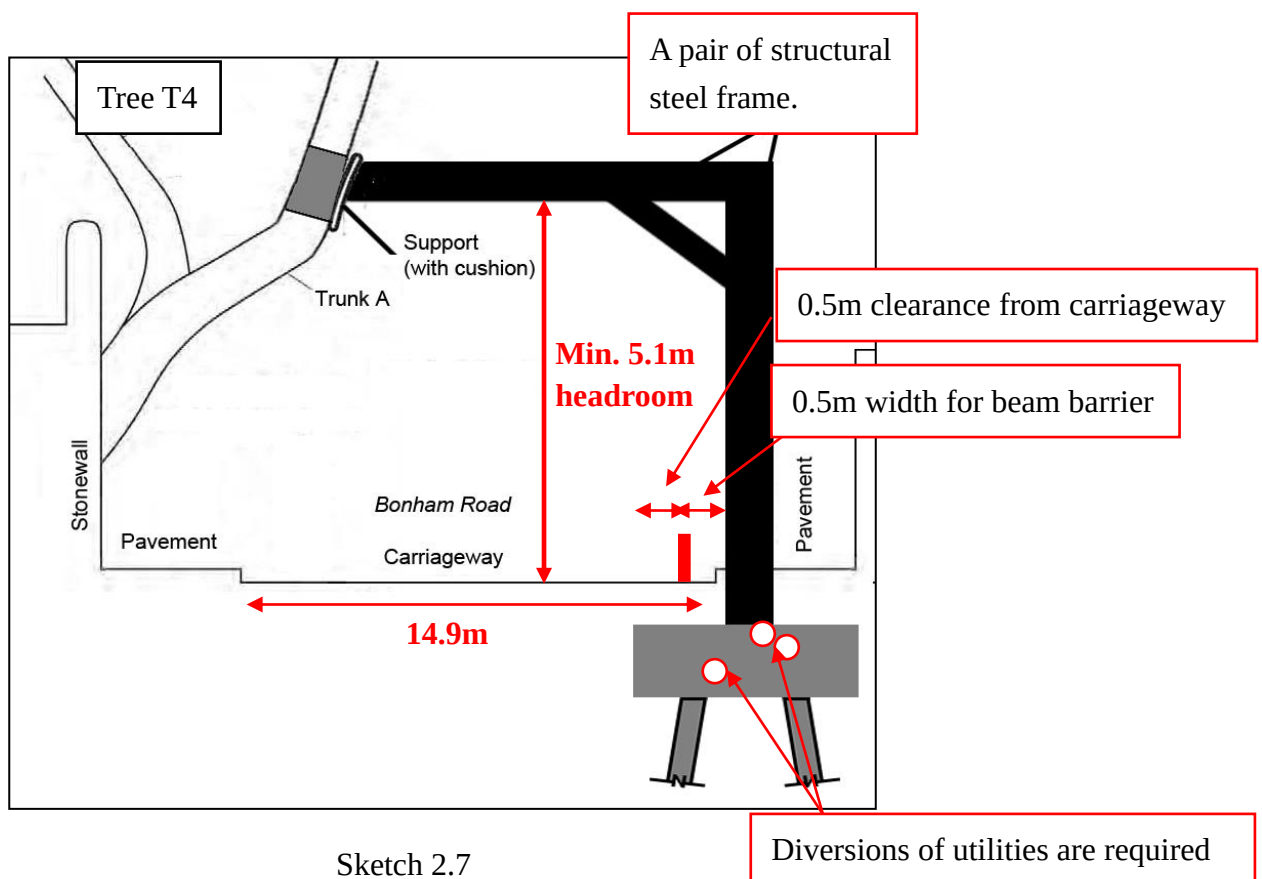
2.9.1 This method is considered infeasible for the following reasons:

- (i) As the proposed structure will span over the carriageway of 14.9m width, the bending

- (iii) Large supporting moment (in the order of 7000KNm for T4 and 1400KNm for T5) to support or stabilise the trees by the steel pole and foundation is required to counterbalance the bending moment induced from the dead weight of the trees and wind loads acting on the trees. The long cantilever arm also induces very large bending moment and torsion. The foundation of the steel structure has been preliminarily assessed to take the form of six raking mini-piles. The pile cap is in the order of 3.7m x 4.7m. According to the utility records, there are underground utilities with at least one drainage pipe, one water pipe, and one gas pipe located at the northern footpath of Bonham Road. Underground utilities also exist at the opposite footpath so that the space available for utility diversion is limited. Underground utilities diversion will result in closure of traffic lane at Bonham Road for a long period and will cause serious traffic disruption.

- (iv) The proposed massive structure will cause unacceptable adverse visual impact.
