Shaukiwan Road

Stanley Road

Pok Fu Lam Conduit

22 masonry bridges and aqueducts, 4 drainage culverts

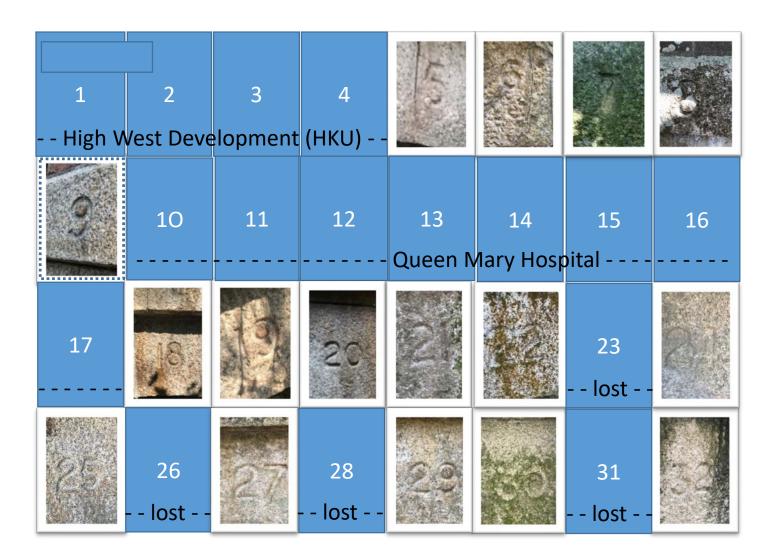
The Pok Fu Lam Conduit included 32 aqueducts between Pokfulam Reservoir and the West Point filter beds (near what is now known as the Lung Fu Shan Environmental Education Centre). A recent survey shows that 16 are still in tact. Number 9 is graded as a heritage structure.
