## 建造業議會

### 申請大埔 33 區地作為設置戶外訓練場之建議

CONSTRUCTION  
INDUSTRY COUNCIL  
建造業議會

Feasibility Report

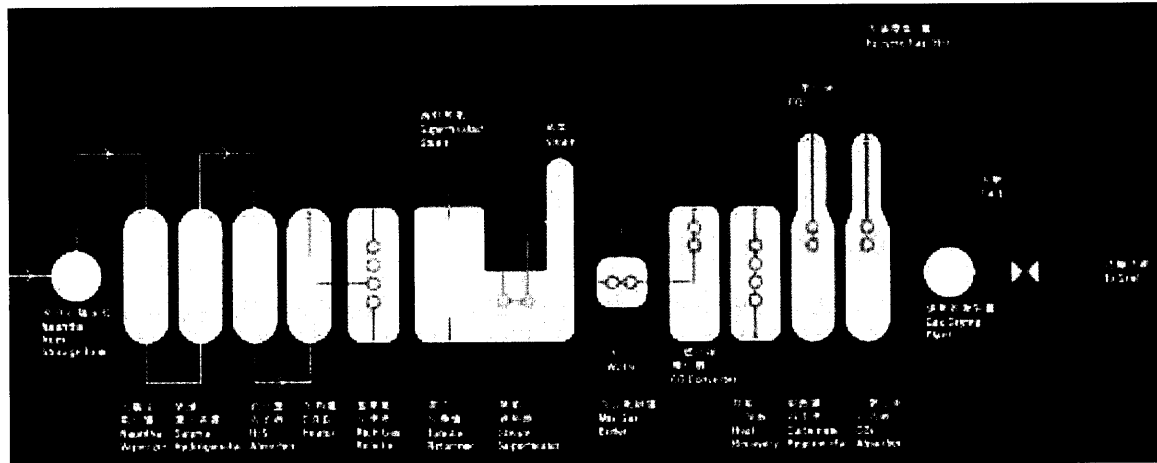
**Figure 6.1 Tai Po Plant – Catalytic Rich Gas (CRG) Process**

- 6.2.6 The carbon monoxide present in the reformed gas product is reduced by the shift reaction in a high-temperature converter, increasing the content of hydrogen.

- 6.2.7 To achieve the specific gravity of town gas, the content of carbon dioxide is reduced by a hot potassium carbonate solution. Part of the converted gas is then cooled, and carbon dioxide content is lowered to 1 percent before the gas is mixed with the rest of the converted gas. The gas is then cooled and dried, and an odorant is added to the gas to give town gas a distinctive smell before the town gas production cycle is complete.

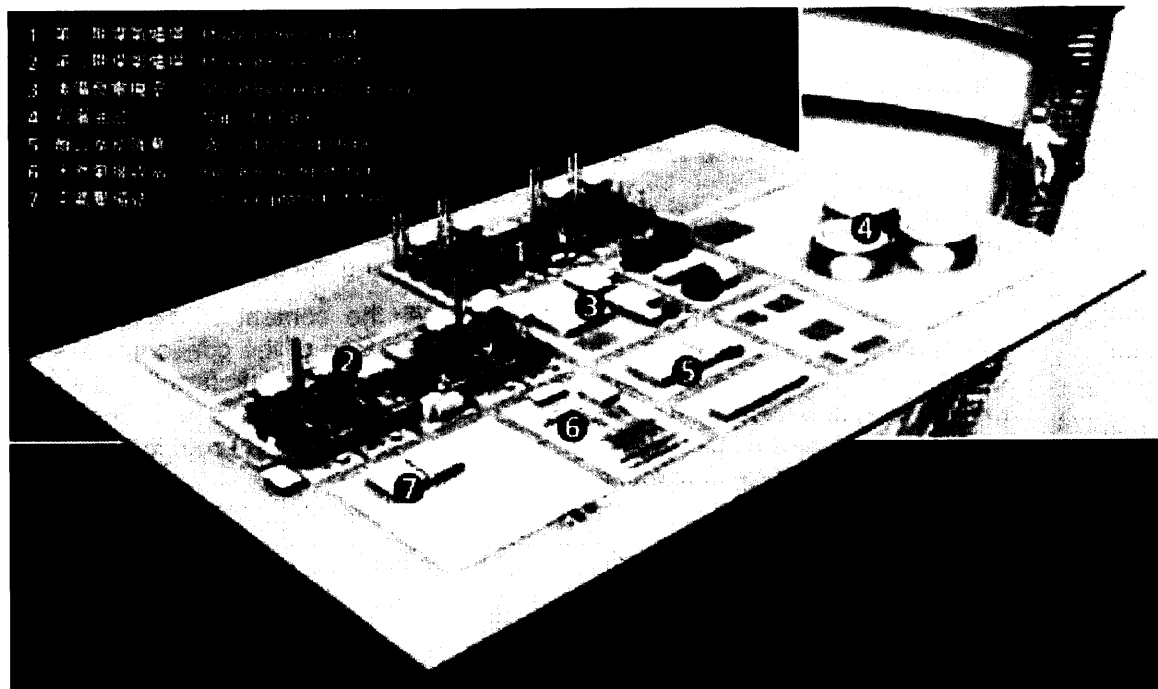
**Figure 6.2 Tai Po Plant – Production Facilities**

- 6.2.8 Naphtha is converted into a methane-rich gas through low-temperature steam reforming. Natural gas is delivered to a catalytic tubular reformer in which it reacts with steam at a high temperature, becoming a lean gas. The resulting lean gas is mixed with rich gas in a fixed ratio to achieve the required calorific value of town gas. The rest of the process is similar to the pure naphtha production process except that there is no need to reduce the carbon dioxide content.
- 6.2.9 Town gas is distributed at a maximum pressure of 3,450 kilopascals (kPa) as a clean, gaseous fuel that is about half the density of air.

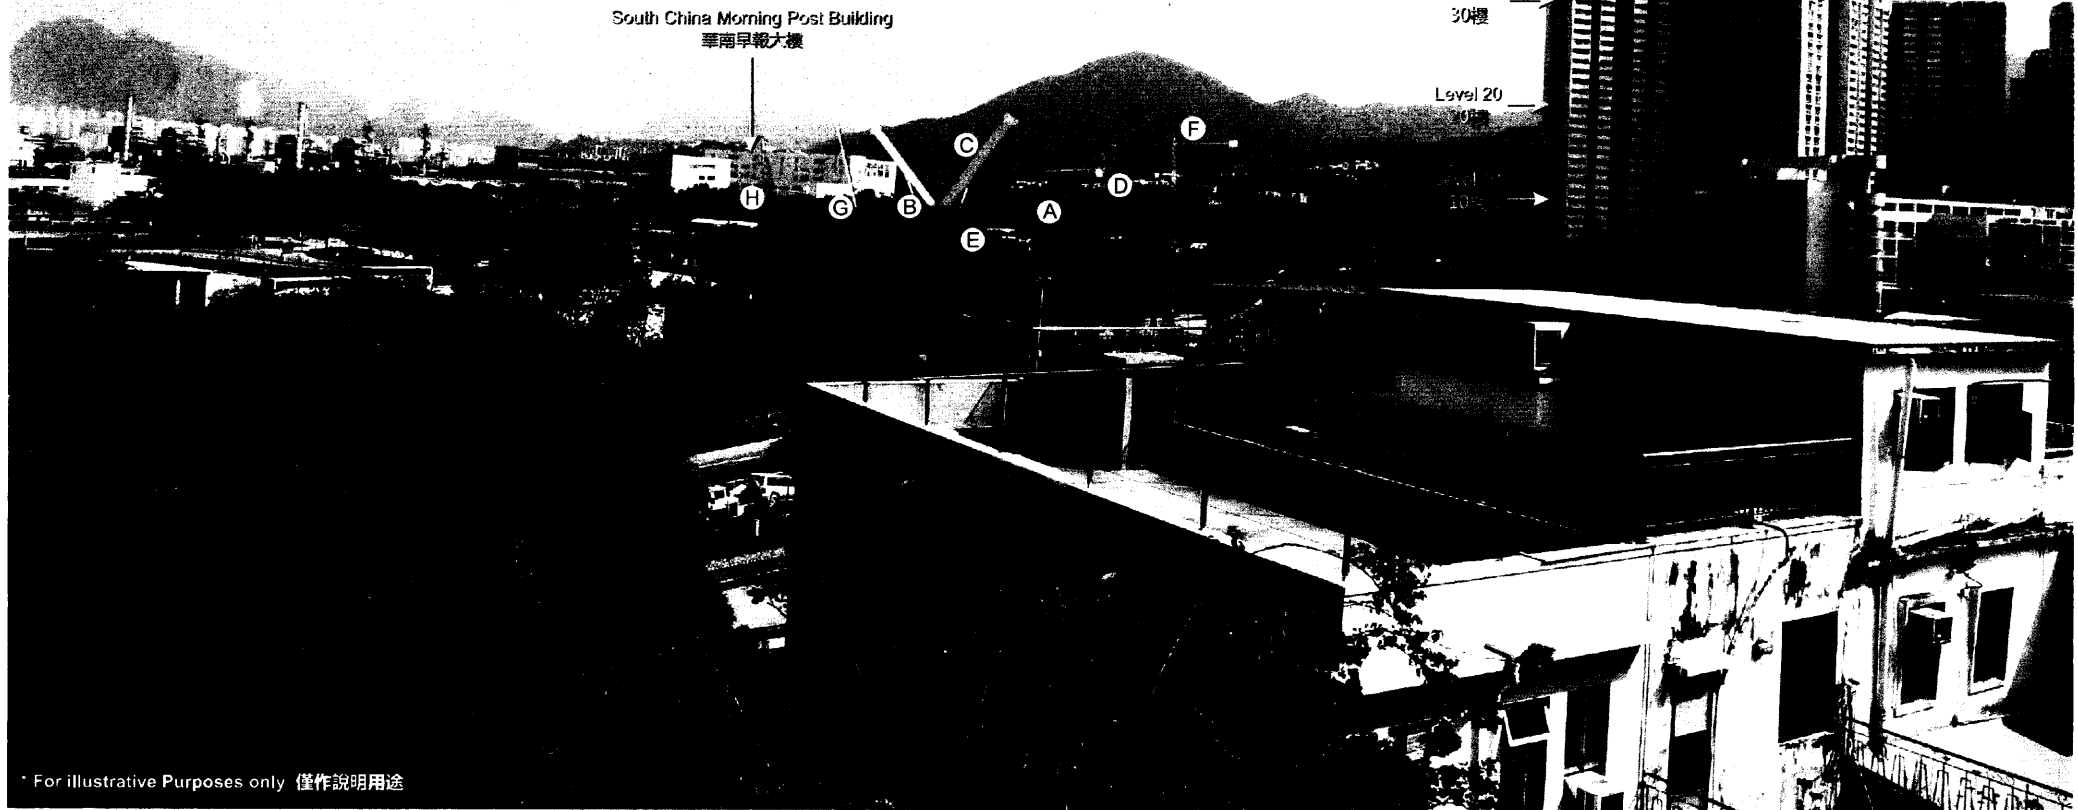
Viewpoint 2 - View from Yue Kok Village with Proposed Project (with possible mitigation)  
觀點二: 從魚角村瞻望提議的工程項目位置(有可能的緩減措施)
