Proposed agenda item for the 18th TTC meeting on 10th November 2014:

Request for Government Departments and Transport Operators to Step up Measures to Prevent High Capacity Passenger Vehicles Falling off Roadside Slopes

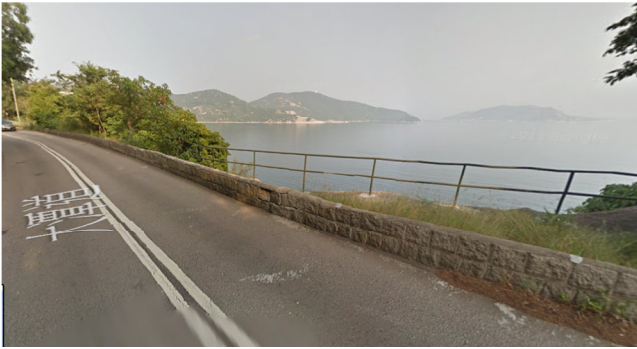
A narrow section of Tai Tam Road (Red Hill to Stanley) adjacent to a 20m high sea cliff. The stone wall does not have the capability to resist impact by buses and coaches at general speeds.

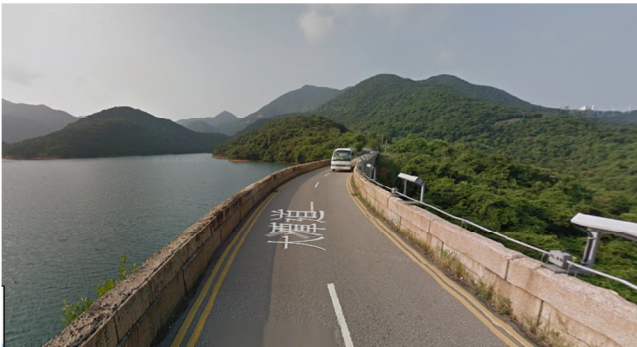
Bend on Tai Tam Tuk Dam. The collision between two private cars on 30 August 2014 resulted in the detachment of sections of the stone wall. This clearly indicates that the wall cannot withstand impacts by buses and coaches. Some double decker drivers adopt excessive speeds on the straight sections, presumably in an attempt to reduce the waiting time of opposing vehicles. Observation has been made in a bus with its speedometer showing 60km/h over the dam. In order to control the risk of accidents, travel speeds of buses and coaches have to be regulated to not more than 35km/h.

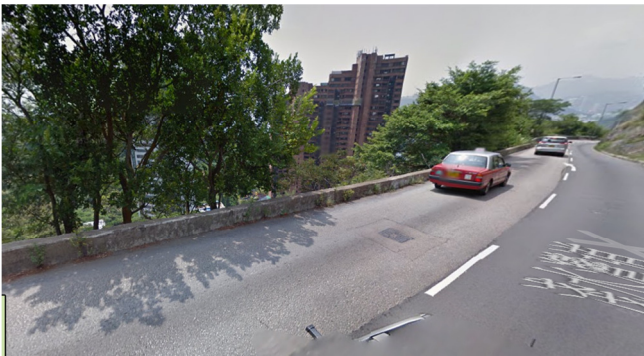
A section of Repulse Bay Road over a 20m high steep side slope.

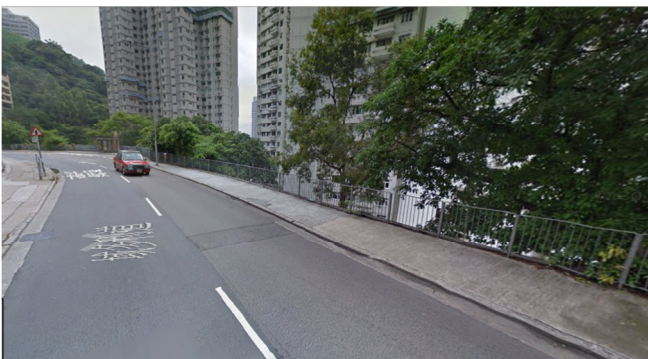
A 100m long section of Victoria Road over a cliff
