FORM 2: TREE RISK ASSESSMENT FORM
表格 2: 樹木風險評估表格

Department 部門:	ArchSD	Inspection Officer 巡查人員:		Post 職位:	ITSQA
File Ref. 檔案編號:	_20160704	Endorsement Officer 覆核人員:		Post 職位:	Project Manager
Date of Inspection (yyyy/mm/dd) 巡查日期:	14-Jun-2016	Last Inspection Date (yyyy/mm/dd) 上次巡查日期:	21-Mar-2016		
Project / Contract No. 合約/工程編號:	TC B928				
Inspection Frequency 巡查週期:	Once every 3 months

Tree ID 樹木編號:	TS013	Departmental reference 部門編號		OVT no 古樹名木冊編號	ARCHSD CW/41				
Tree Species 樹木品種:	Ficus microcarpa								
Location 地點:	Street/ Road No. 門牌號碼	11SW-B/FR260	Street/ Road Name 街道名稱	Hong Kong Park					
	District 地區	A	Nearby Utility Post No. 就近公用設施編號:						
Coordinate 坐標 (HK1980 GRID):	X-Coordinate		Y-Coordinate						
Location Types 地點類別: (multiple answers allowed 可選多於一項)	<input type="checkbox"/> Roadside Landscaped Area 路旁綠化地區		<input type="checkbox"/> Central divider 中央分隔帶		<input type="checkbox"/> Tree pit 樹穴				
	<input checked="" type="checkbox"/> Public Park 公園 / 康樂場地		<input type="checkbox"/> Unallocated Government land 未撥用的政府土地						
	<input type="checkbox"/> Remote countryside 偏遠郊區		<input type="checkbox"/> Recreational site/facilities inside Country Park 郊野公園內康樂用地或設施						
	<in

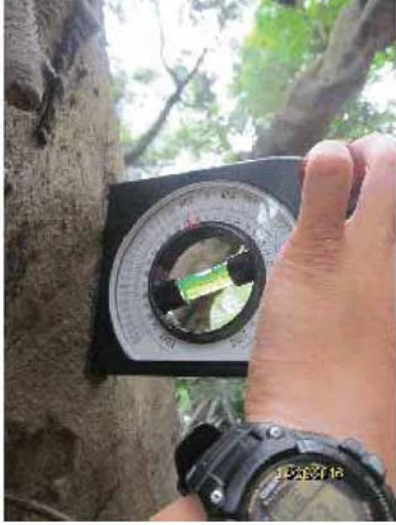
<p>V33 Tilt test 1 (3): Direction 2 Degree: ~ 16</p>

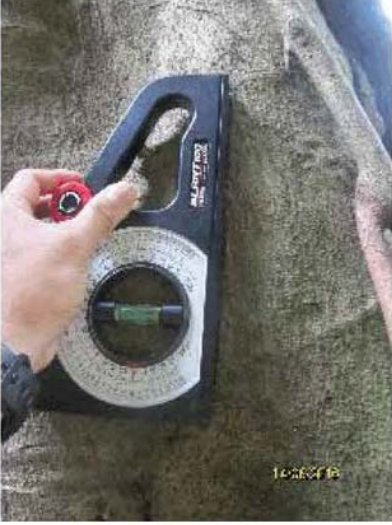
<p>V35 Tilt test 2 (2): Direction 1 Degree: ~ 0</p>

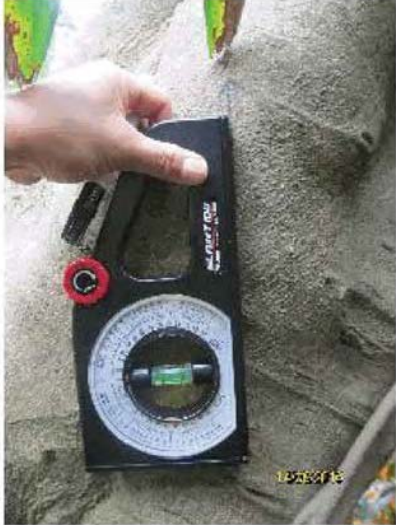
<p>V38 Tilt test 3 (2): Direction 1 Degree: ~ 0</p>

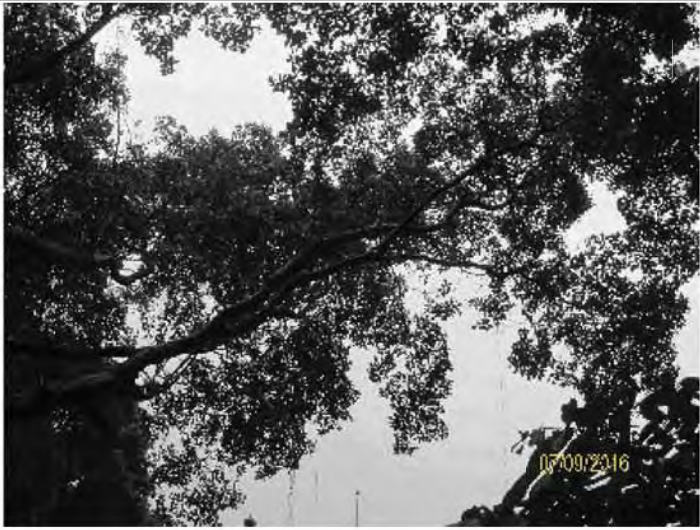
<p>V5 Relative sparse foliage (1)</p>

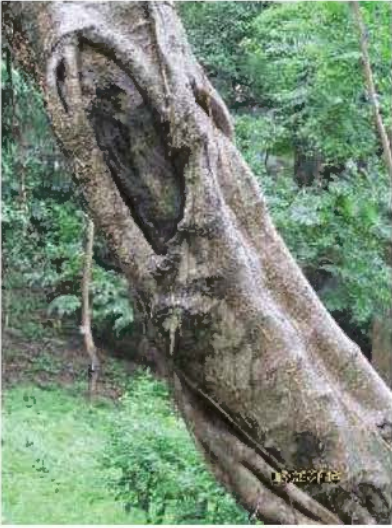
<p>V13 Wound (1)</p>

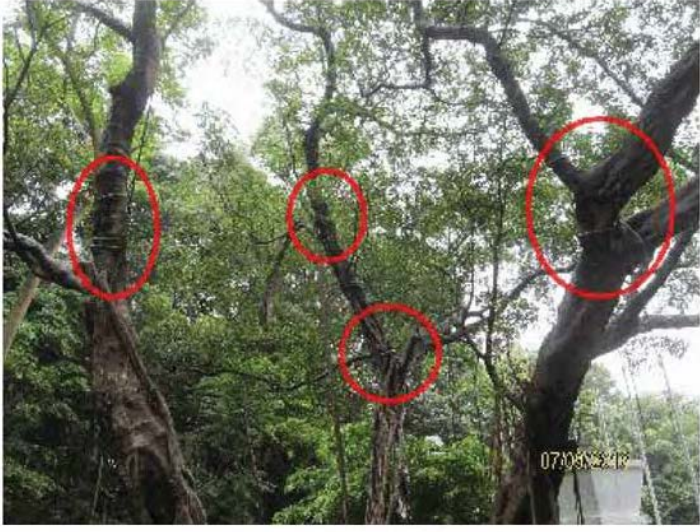
<p>V21 Cabling 1 (1)</p>

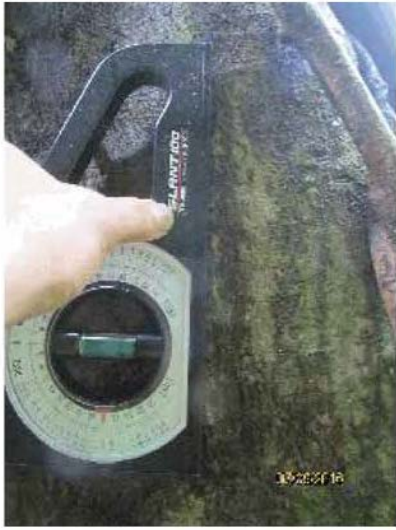
<p>V39 Tilt test 2 (3): Direction 1 Degree: ~ 0</p>

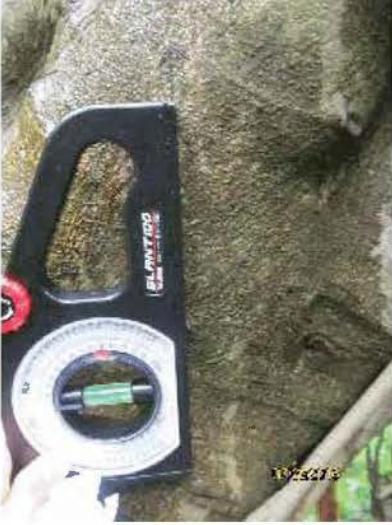
<p>V43 Tilt test 3 (3): Direction 1 Degree: ~ 0</p>

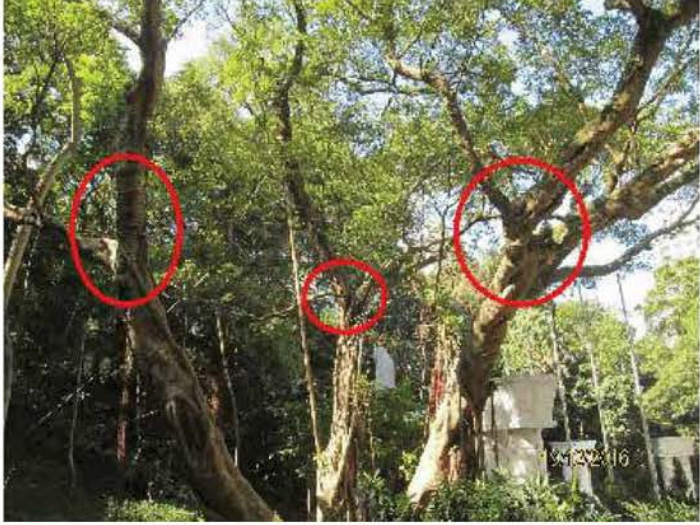
<p>V15 Cabling 1 (1)</p>

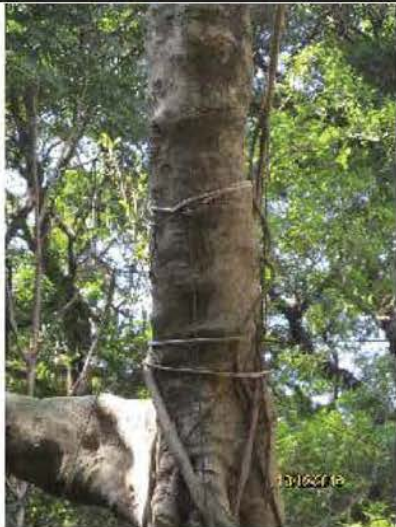
<p>V16 Cabling 1 (2)</p>

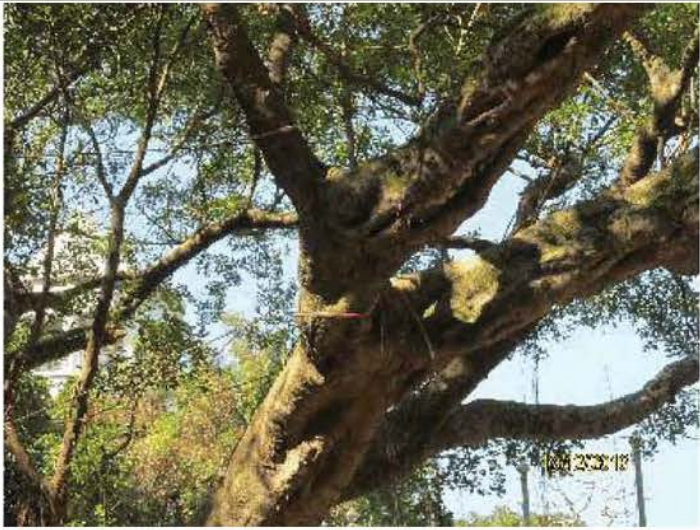
<p>V17 Cabling 1 (3)</p>

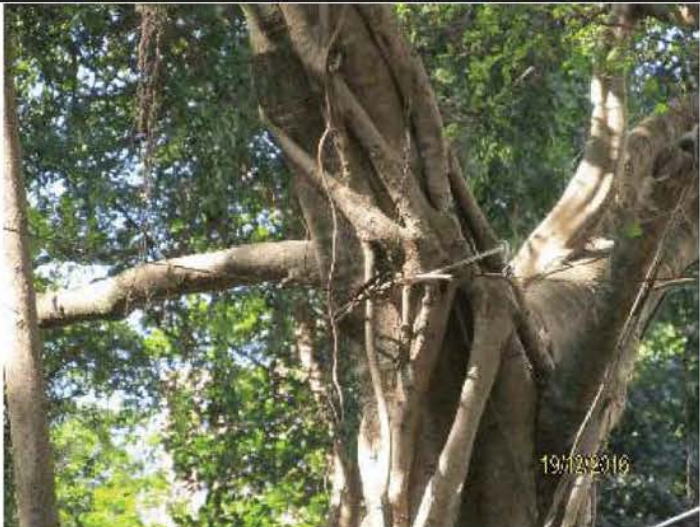
<p>V18 Cabling 1 (4)</p>

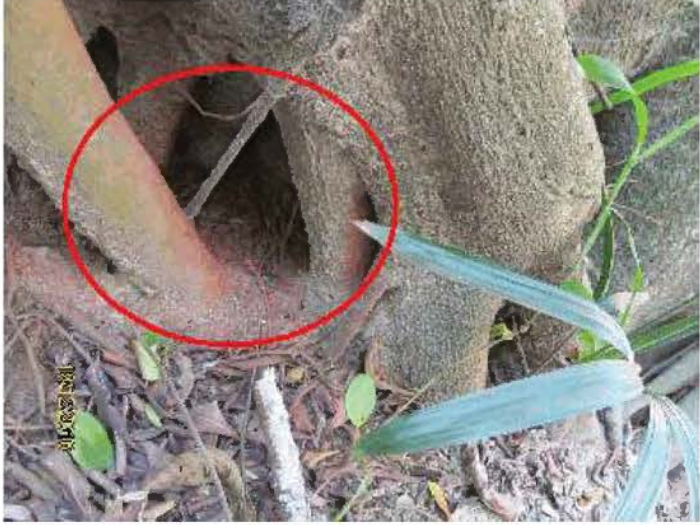
<p>V29 Fungi (3): Spore</p>

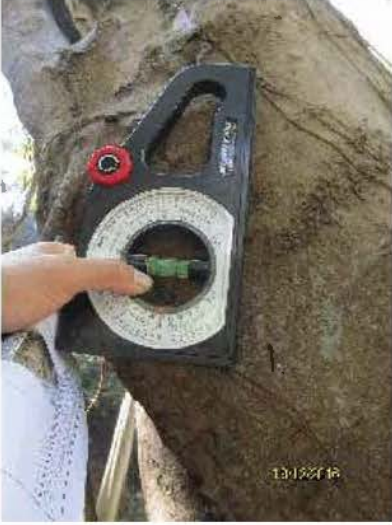
<p>V35 Tilt test 1 (3): Direction 1 Degree: ~ 0</p>

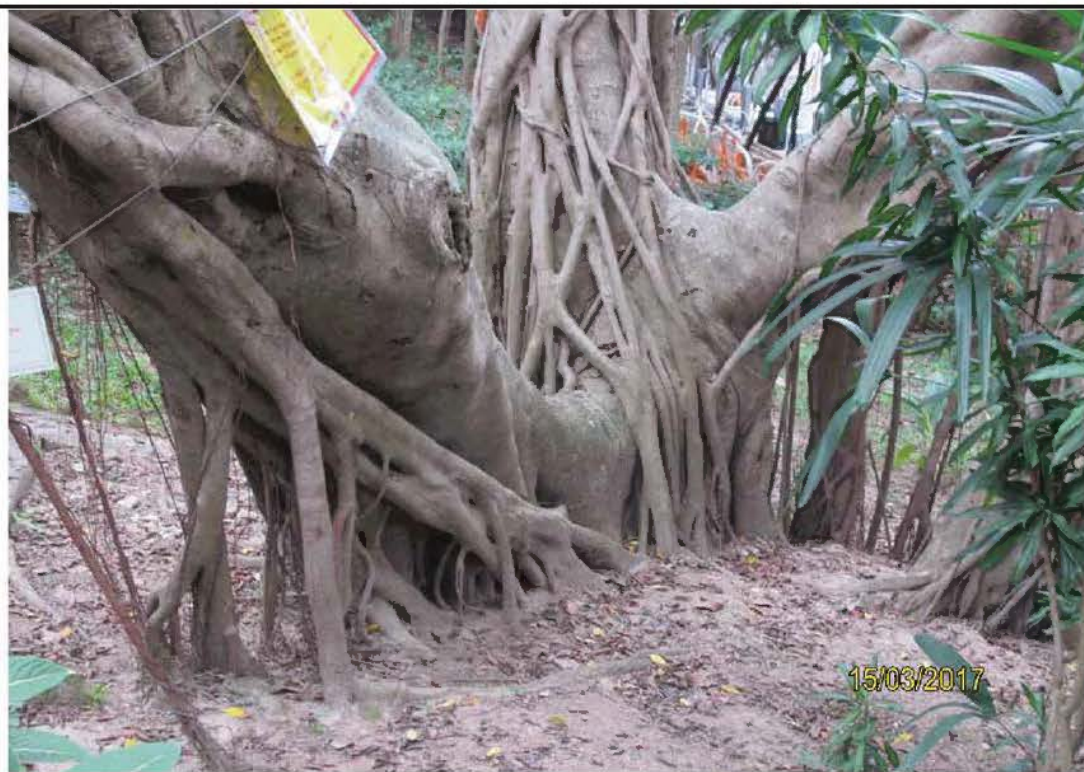
V7 Root 1

- Tree health was observed to be stable compared with 3 months ago. Foliage density was found relatively sparse.
 - Some Ganoderma sp. fruiting bodies and mycelial crust were found at trunk base continuous, fungicide application is suggested.

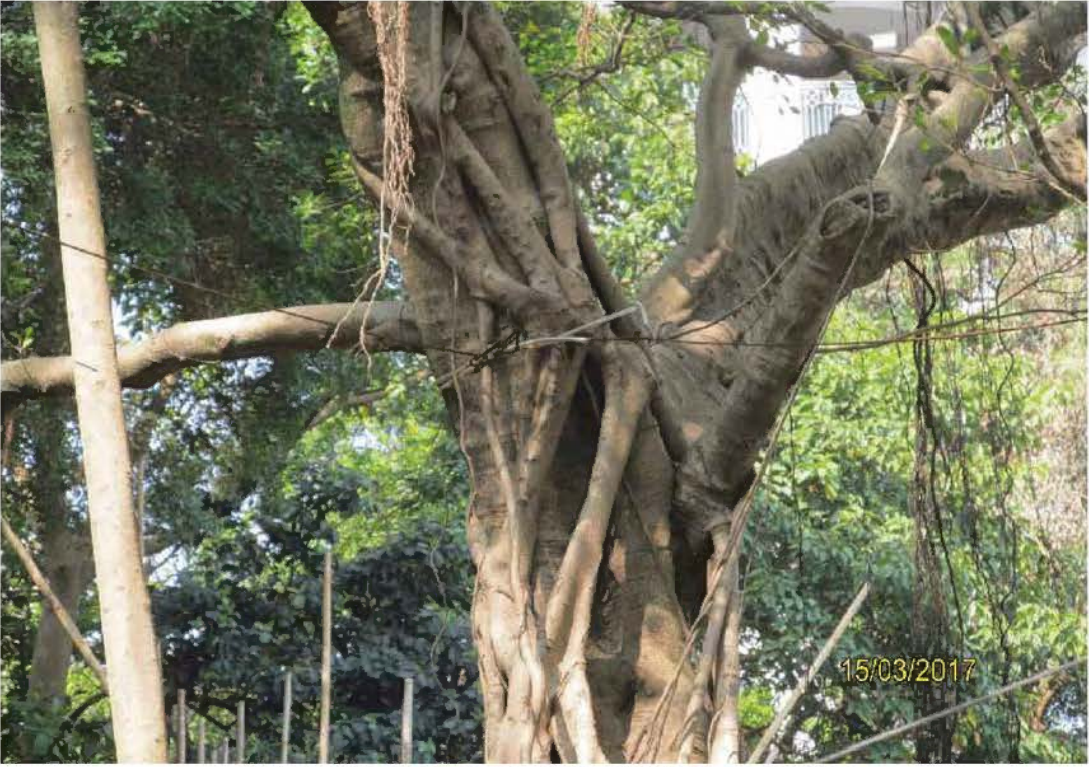
<p>V13 Cabling 1 (3)</p>
--	-------------------------------

- Condition of trunk base and the growth of fungi should be closely monitored.
 - Cobra Triangle cabling system was already installed. Conditions of all cabling were found satisfactory.

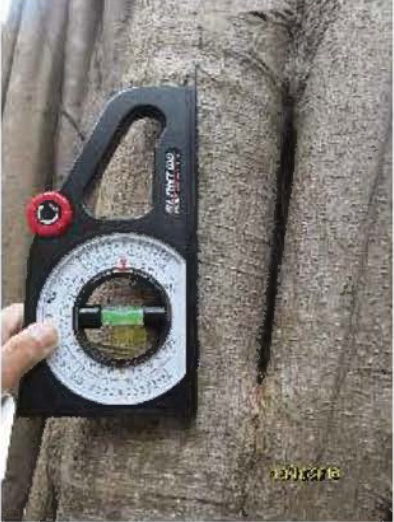
<p>V19 Tilt test 1 (3): Direction 1 Degree: ~ 0</p>

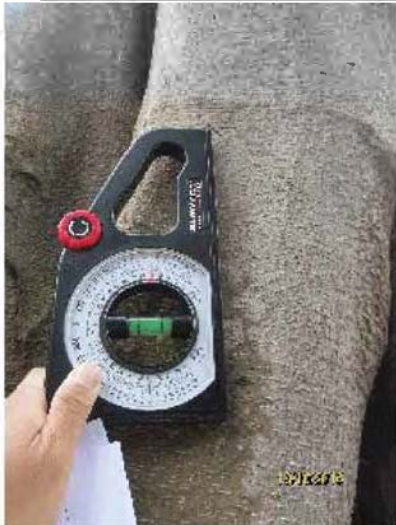
<p>V23 Tilt test 2 (3): Direction 1 Degree: ~ 0</p>

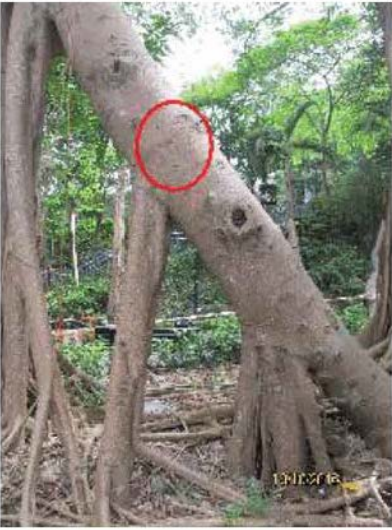
<p>V25 Tilt test 3 (1): Marking</p>

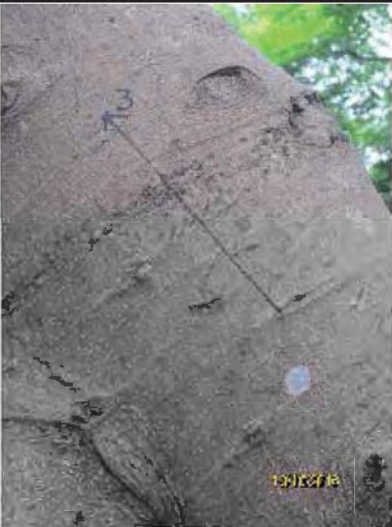
<p>V26 Tilt test 3 (2)</p>
